Parlee Beach Provincial Park Channel Assessment Study & Report

NB Department of Tourism, Heritage and Culture

TECHNICAL REPORT

February 14, 2019

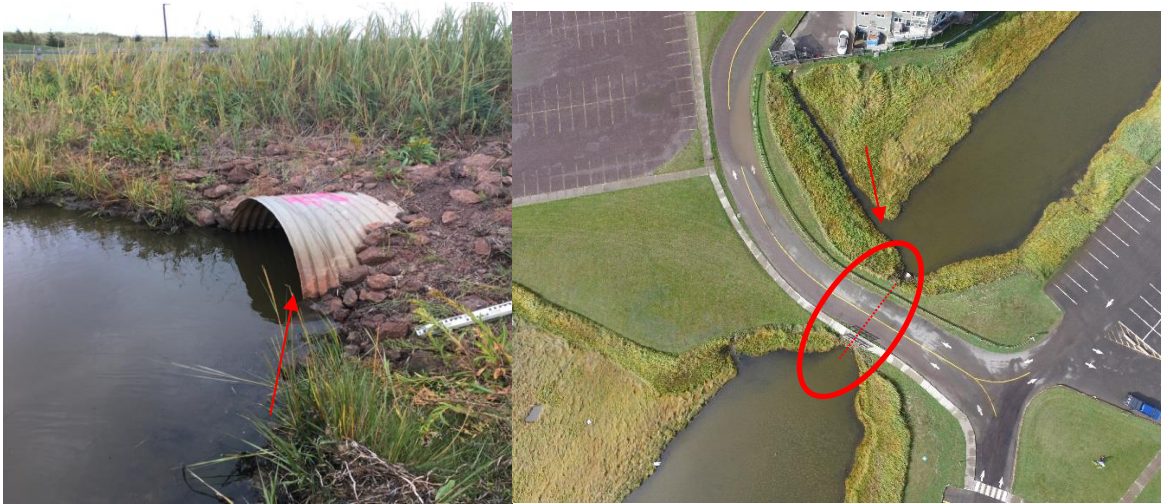
Figure 2-3: Culvert no. 1 (1200mm Diameter Corrugated-Steel Pipe (CSP))

*Poor Extensive surface corrosion, deep pitting, perforations and overall thin weak metal.
 *Fair Corrosion and scaling, however, no major structural damage
 **Removed Pipe was removed during the study

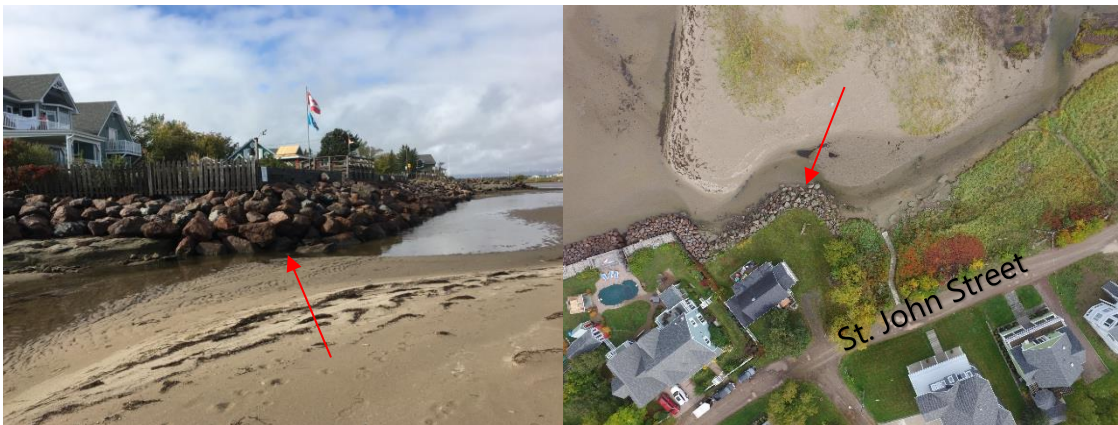
Figure 2-10: Human-Made Rock Wall

A human-made rock wall is located on PID 00864322 at the inlet of the channel and was constructed sometime around 2001 in order to protect private property from erosion, as determined by the aerial photo also attached in Appendix C. Prior to rock wall existed a timber wall for erosion protection. The wall is approximately less than 2 m in height and extended less than 3 m seaward from edge of SNB property lines. Armour stone (large rip rap) with an average diameter of 500mm to 1,000mm in size was used, as shown in **Figure 2-10**. The rock wall is located outside the PSW buffer.

According to the Coastal Areas Protection Policy for New Brunswick that was developed around this time (2002), erosion control works such as rip rap, sea walls and bulk heads do not require a formal environmental review, provided they met the following criteria:

1. *Evaluate the feasibility of removing or moving back the existing rock structure at the mouth of the channel. It is recommended that NBDTHC obtain legal advice on the responsibilities for this given it was constructed by a private landowner.*

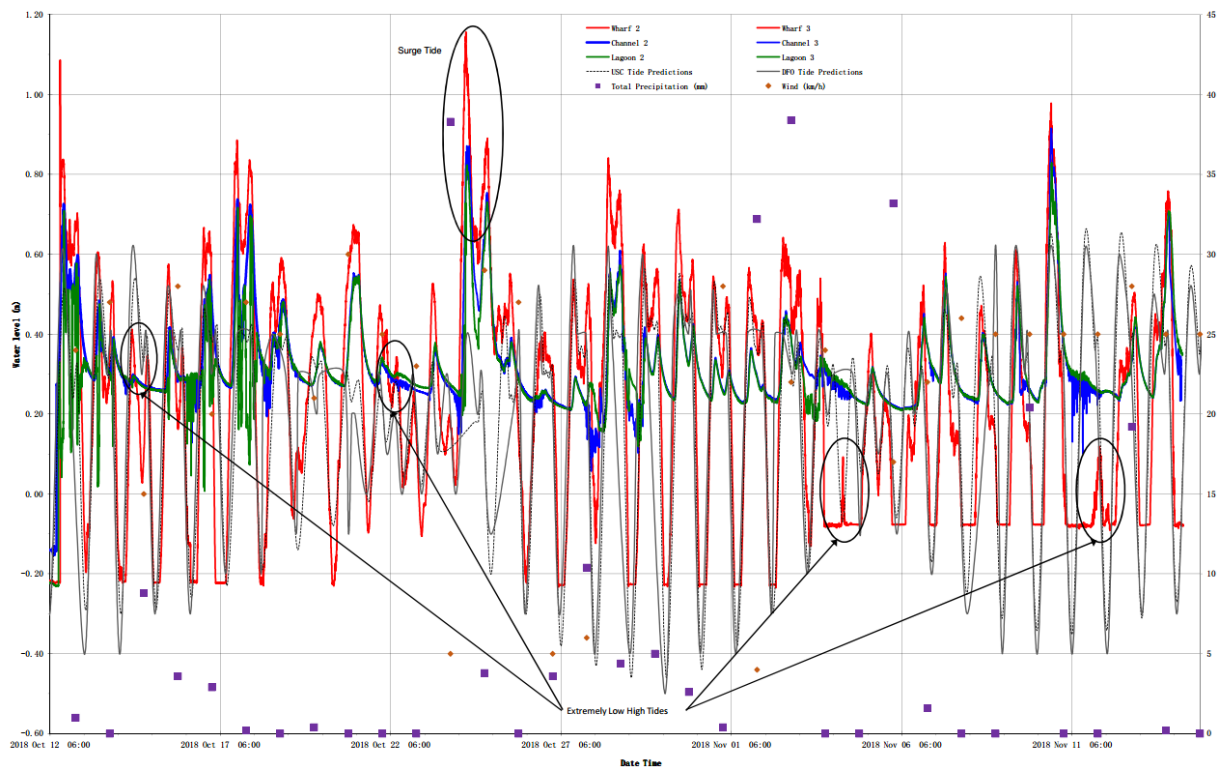
Figure 3-2: Tidal Curves from Oct 12 - Nov 14, 2018

Significant increases in the channel and lagoon water level usually occur as a result of major precipitation events and storm surges were observed through the study. This was observed on October 24th, 2018 where the lagoon water level increased to +0.8 m geodetic with a rainfall of 38 mm in 24 hours as well as a storm surge shown on **Figure 3-2**.

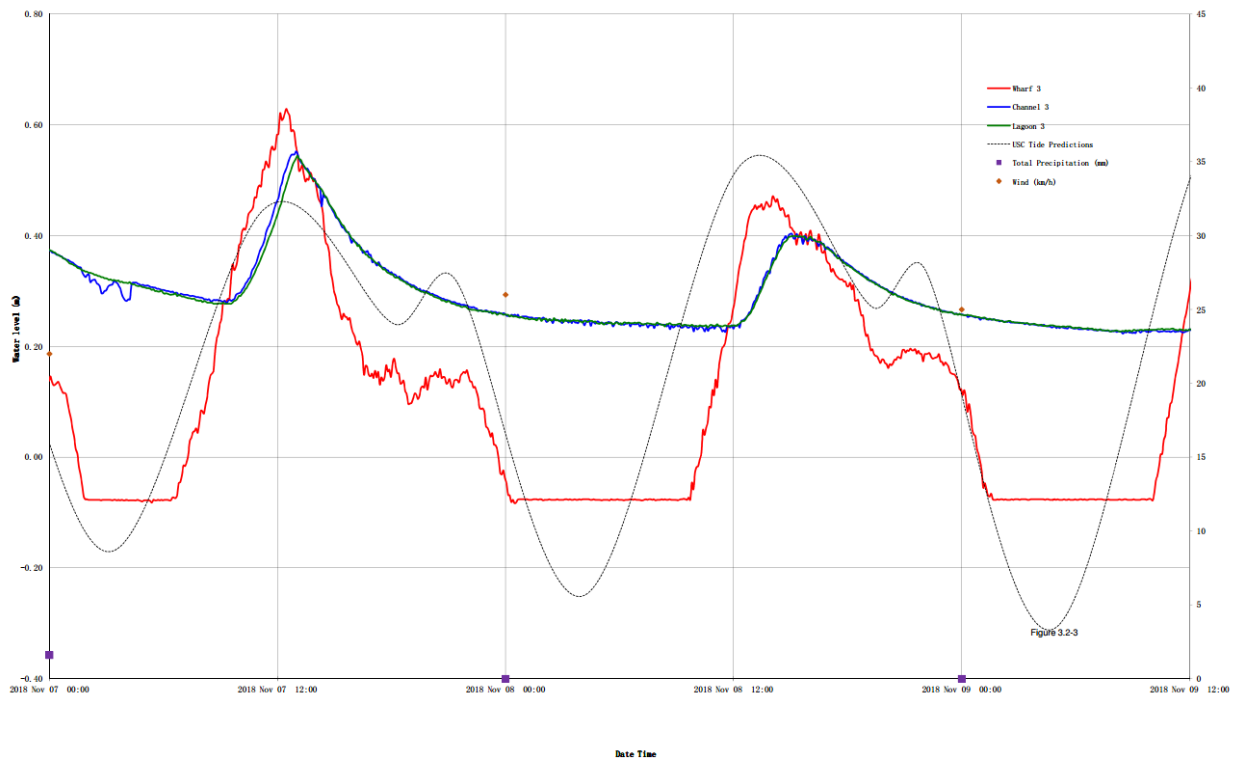
Figure 3-3: Tidal Curves from Nov 7 - Nov 9, 2018

Figure 3-3 show a more detail representation of the inlet restriction to the channel. The channel (blue) and lagoon (green) level loggers trail the Wharf logger (red line) by approximately 1.5 hours on November 7th, 2018. This time is required to build approximately 150mm of hydraulic head to drive the flow into the channel. This delay prevents the channel/ lagoon from peaking at the same level as the wharf before it is met with the dropping tide as described above. This indicates that there is a hydraulic restriction at the inlet of the channel. **Drawing 18292-00P-C03 and Drawing 18292-00P-C11, Appendix A**, shows the inlet from Station 0+850 to the end of the bathymetry at Station 1+000 the channel is both narrower and shallower than the upstream cross sections from 0+850 to the central culver near Station 0+300.

7. Based on a delay in rising tides, we have found that there is a restriction at the inlet based on the delay in rising tide from the Northumberland Strait to the channel due to the narrowing and shallowness of the inlet.

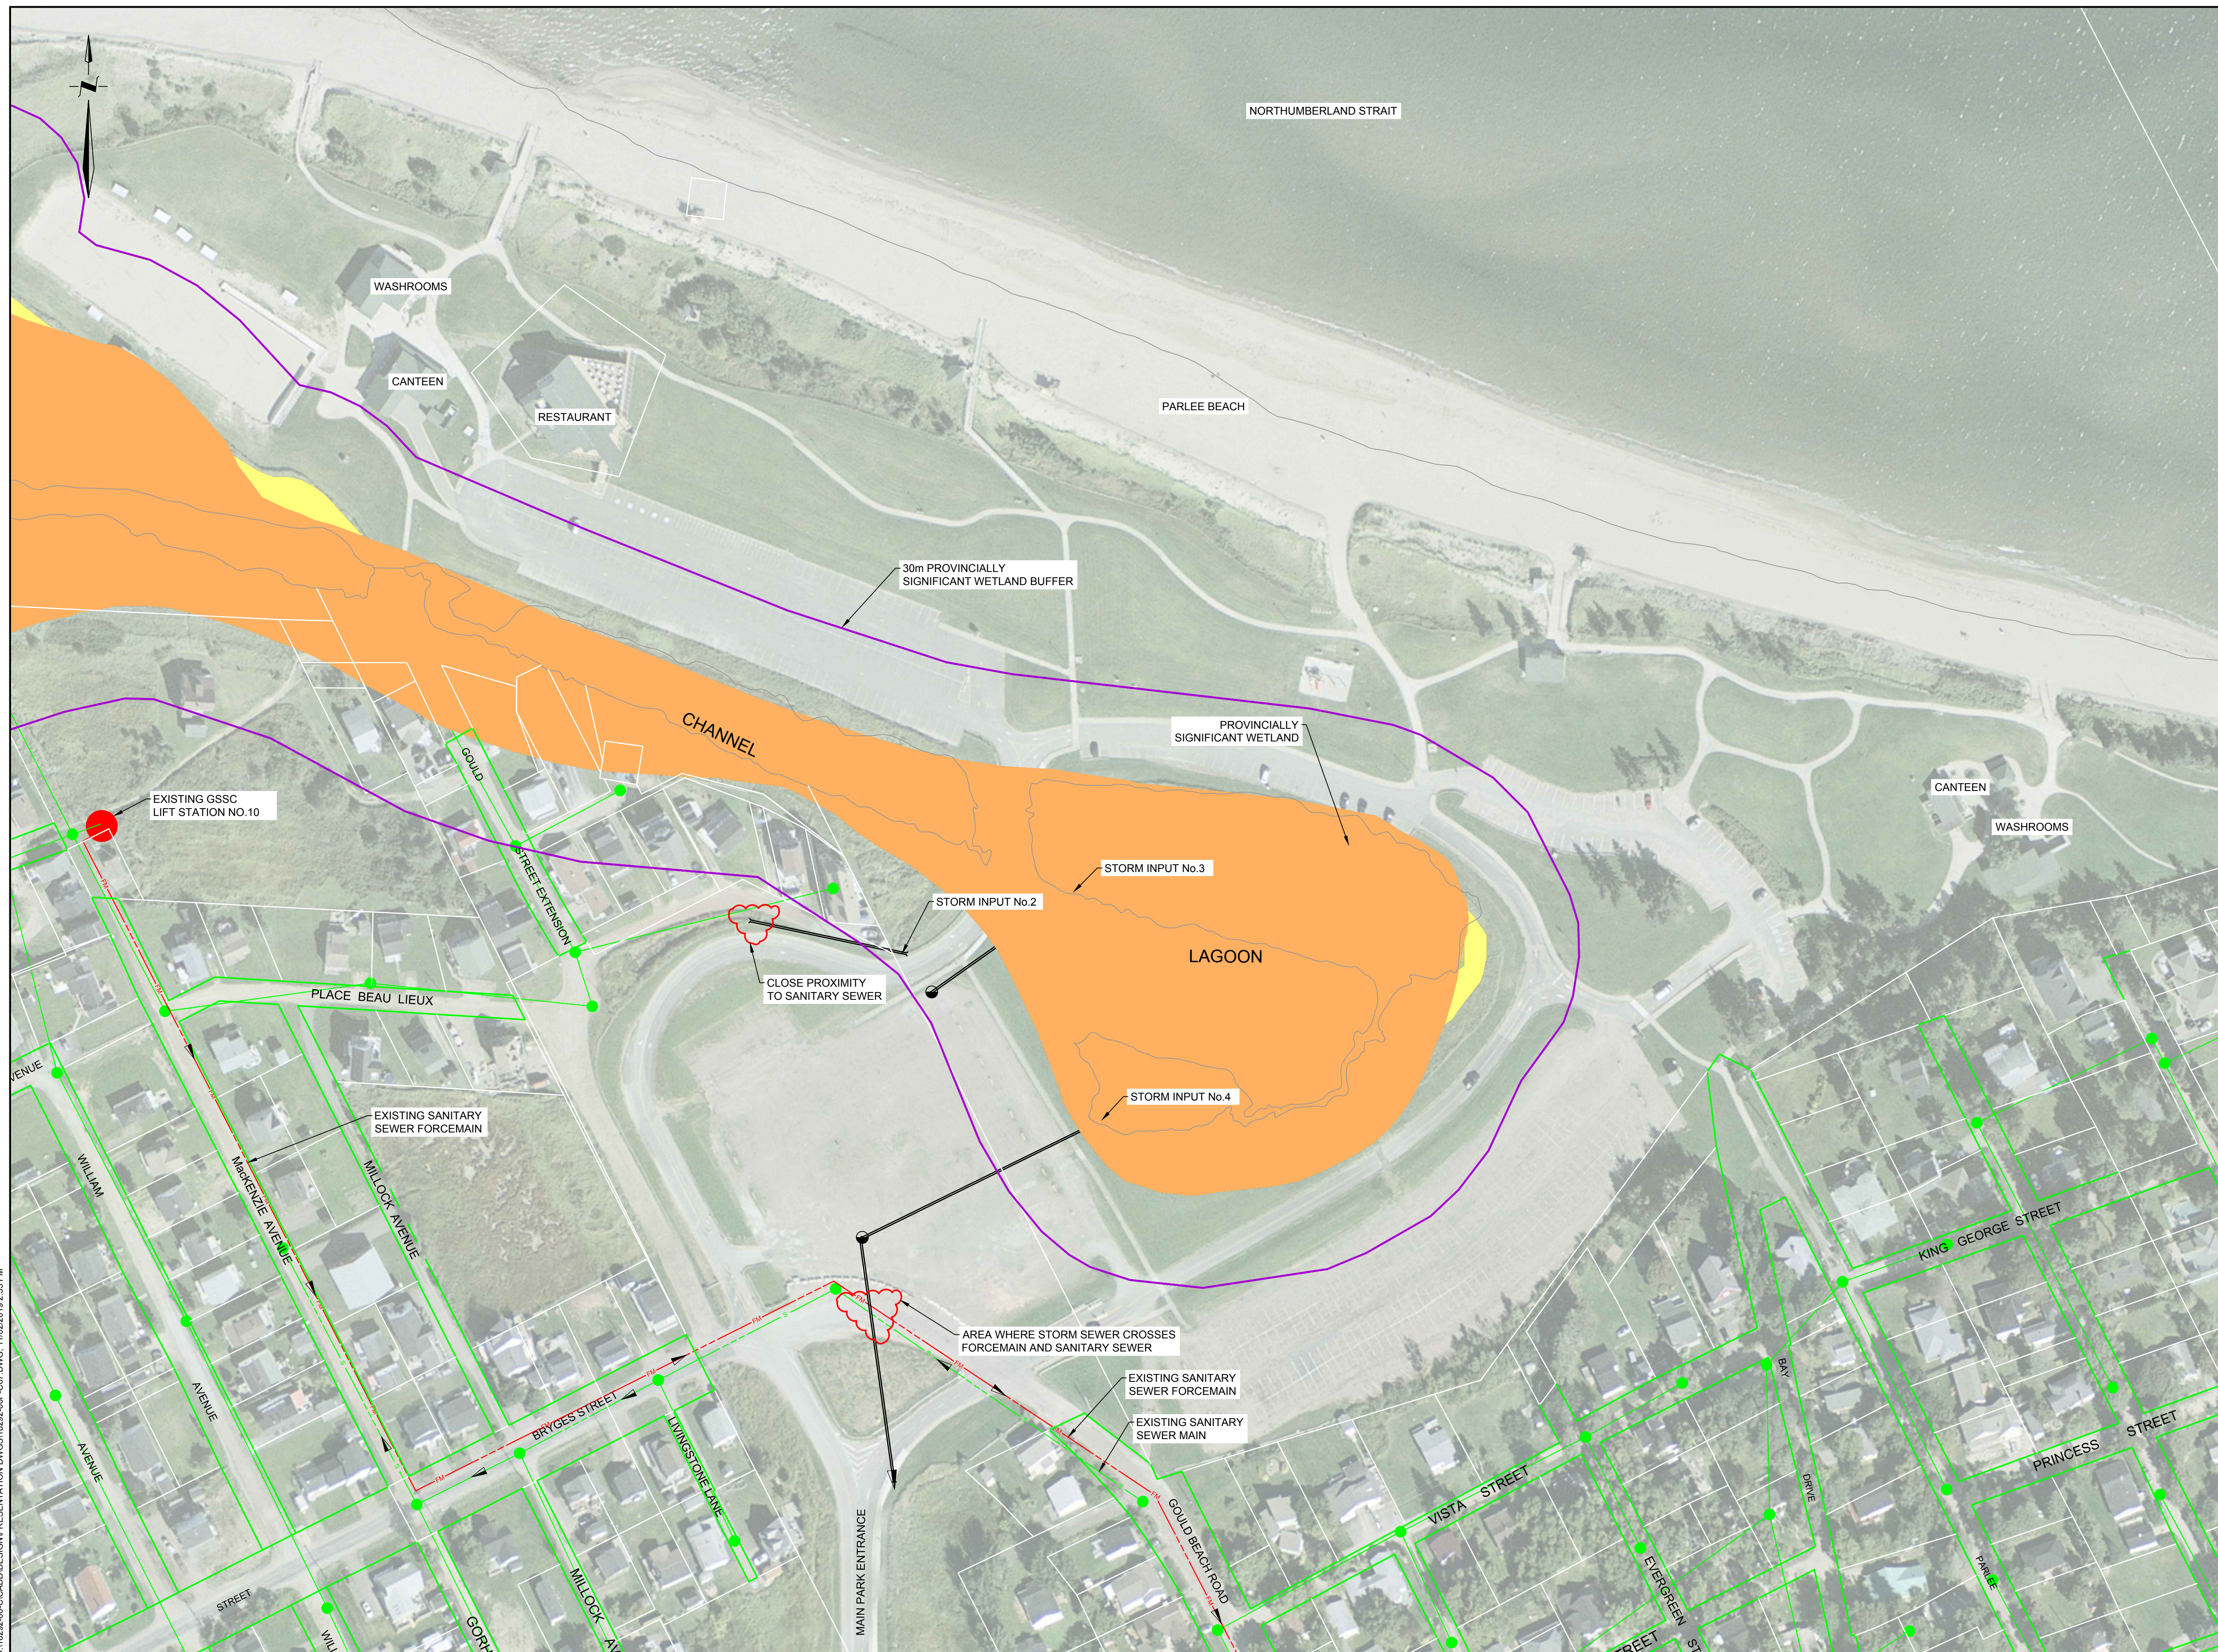
Drawing 18292-00P-C07, shows to areas where the Parlee Beach storm piping is either in proximity or crosses an existing sanitary sewer line.

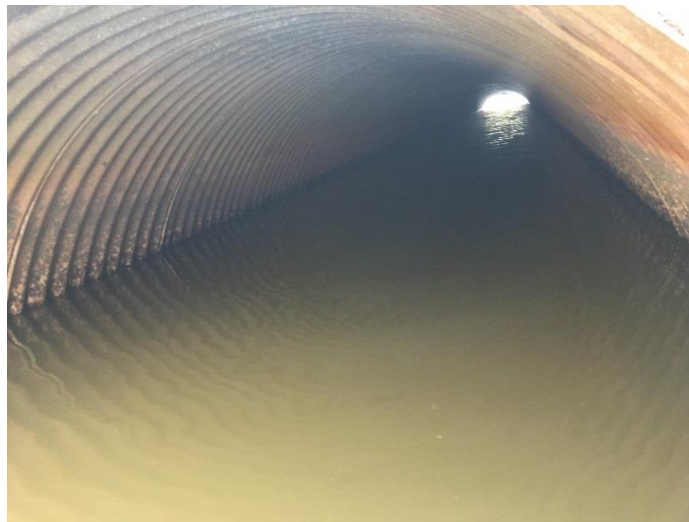
Figure 4-1: Inside Photo of Central Culvert

Most CSP failures are due to corrosion of the wetted perimeter, however, during the inspection, it was difficult to determine if the culvert bottom was corroded as it was covered by 400mm of sediment and was also submerged. It was observed that the existing culverts have minor deformation with a more oval shape and surface corrosion. Condition of the submerged section could not be evaluated during this study.

The present culvert condition was evaluated to be in fair condition and is presently 40% full of sediment. It should also be noted that in the saline conditions CSP has a 20-year life, as a result, this culvert will likely need replacement, based on structural condition alone, by 2029.

During site observations it was noted that the limited opening of the culvert appears to impede on the natural mixing of the water from the upstream "Lagoon" to the downstream "Channel". The flow levels were studied using the level logger data (October to November), during this time the maximum rain event observed on November 3rd, 2018 shown on **Graph 5-1** was when 38.4mm of precipitation fell, equalling less than a 1 in 2-year event. This relatively small event did not produce enough flow to examine the culvert capacity and the lagoon and channel levels were observed to rise and fall at the same rate.

Given the above information, the existing culvert has the theoretical capacity to maintain flow up to a 1 in 50-year storm event, however, on site it was observed that the water quality from between the channel and lagoon differed. The natural mixing between the two bodies of water using the existing culvert is not as good as if the culvert was removed. As a result, a wider span through this section would improve the natural flow of the estuary and reducing organic build-up in the lagoon.

Due to the condition of the existing culvert, its remaining life expectancy, and to restore a more natural mixing flow between the lagoon and channel, it is recommended that the existing CMP culvert, located within a Provincially Significant Wetland, and with limited natural flow, be considered for an upgrade with the following options:

1. *Replace the existing culvert with a box culvert or concrete arch with an opening width of minimum 3.6 m.*
2. *We estimate this order of magnitude cost at \$600,000 + HST.*
