**FISHERIES AND OCEANS  
CANADIAN ENVIRONMENTAL ASSESSMENT ACT (CEAA) 2012  
NEW MILLS CONTAINMENT CELL  
PROJECT EFFECTS DETERMINATION REPORT**

| <b>1. Project Title:</b> New Mills Containment Cell | |
| <b>2. Proponent:</b> Fisheries and Oceans Canada - Small Craft Harbours (DFO-SCH) | |

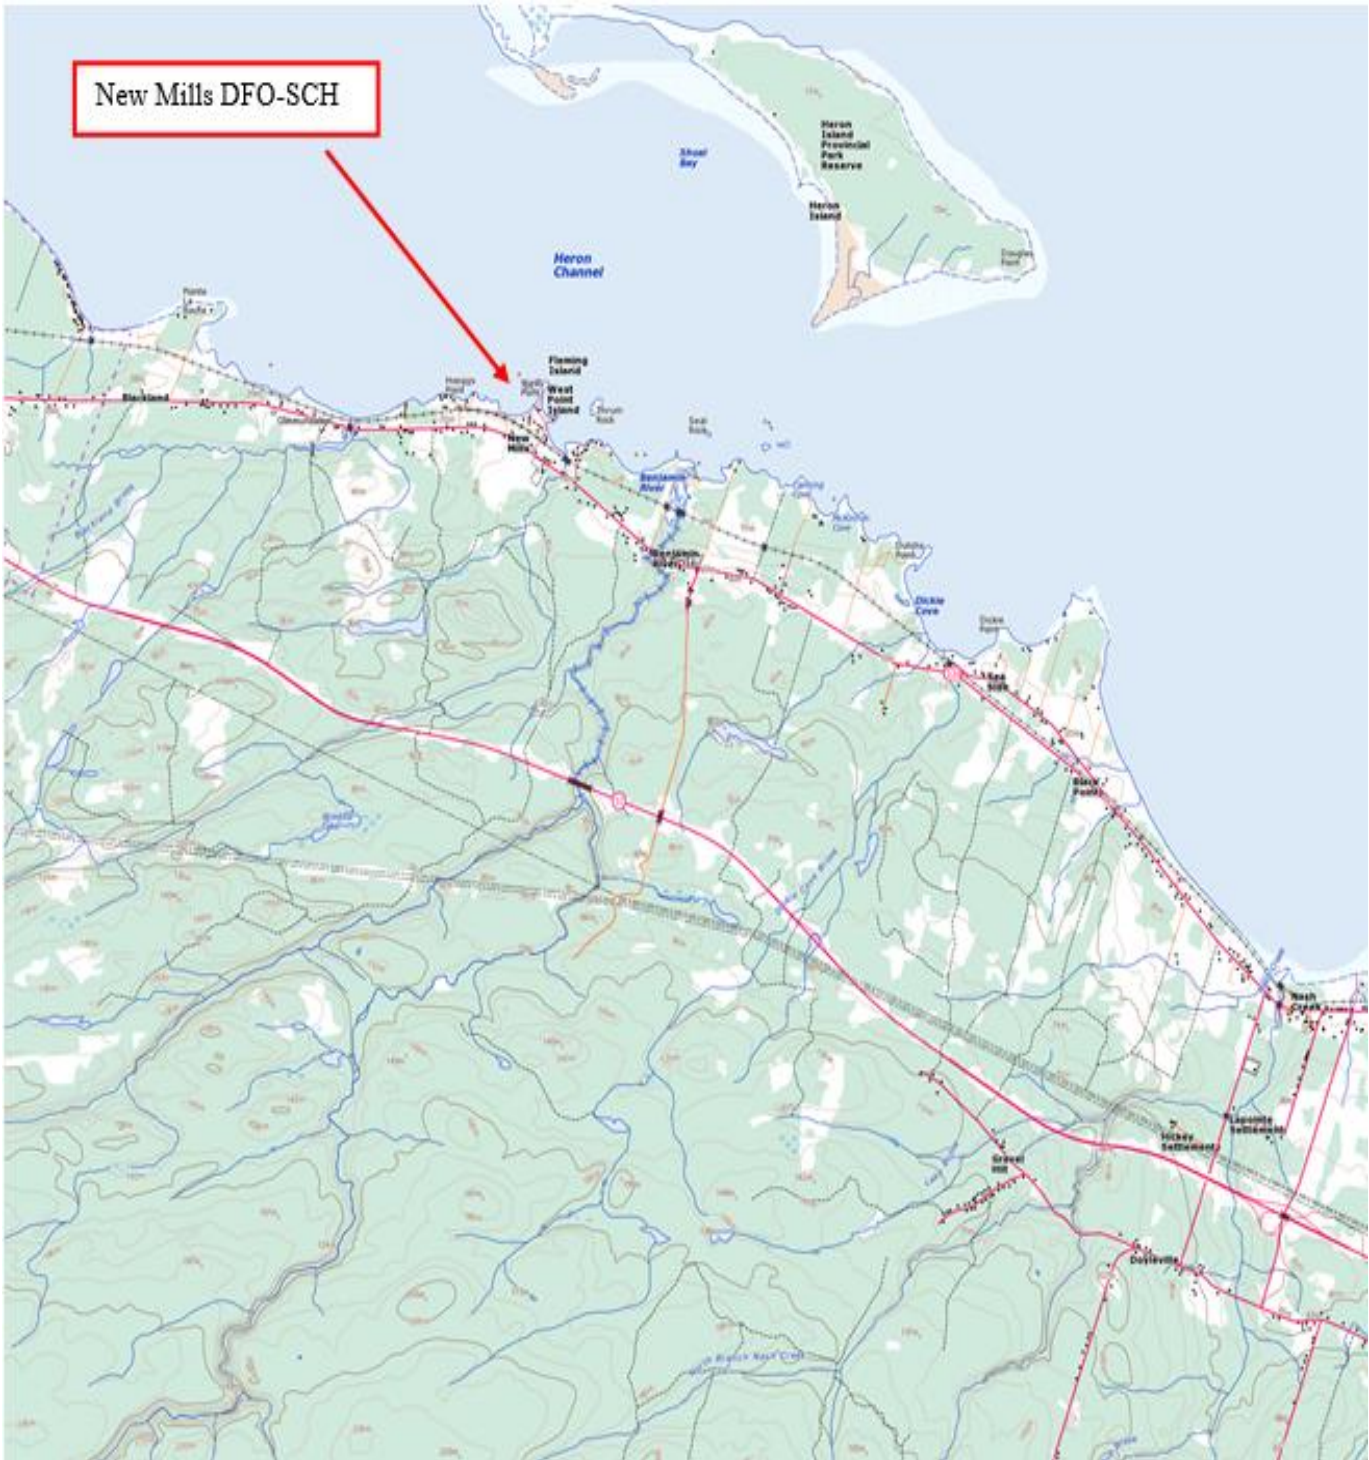
Figure 2: Topographic map identifying proposed project site at New Mills Harbour, Restigouche County, New Brunswick.

The New Mills DFO-SCH (Harbour Code 2601) is located within the Heron Channel of Chaleur Bay along the northern shore of New Brunswick in Restigouche County. The approximate coordinates of the project area are Latitude 47°58'29"N and Longitude -66°11'18"W. Refer to **Figures 1 to 3 in Appendix A** for maps and an aerial photo showing the proposed project location and surrounding area.

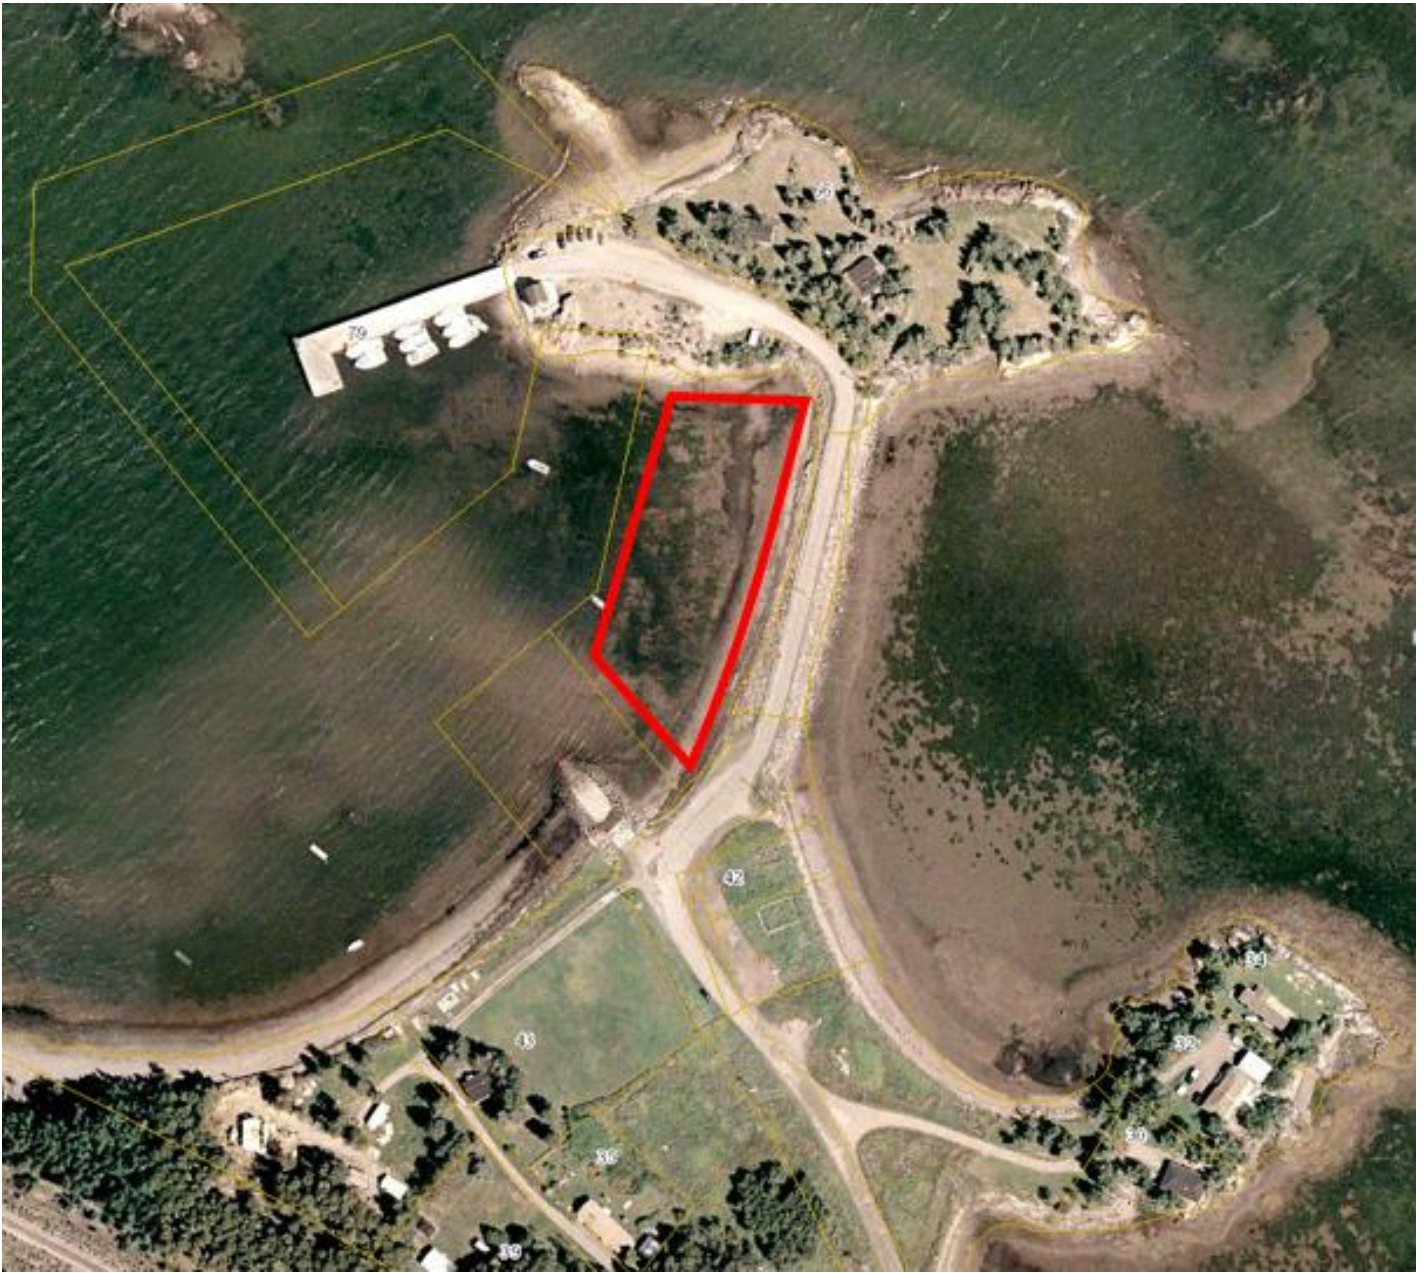
Figure 3: Aerial photo of New Mills DFO-SCH with location of proposed containment cell indicated in red.

It was determined that a containment cell constructed on the west side of the causeway below the High Normal Tide (HNT) mark is the most suitable area. The footprint of the cell will be kept to a minimum (built higher to reduce total footprint) in order to minimize the impacts on the eelgrass bed. Furthermore, the project will adhere to all mitigation measures proposed by DFO-Fisheries Protection Program (FPP) in a letter of Advice. If a *Fisheries Act* Authorization is required, measures proposed by DFO-SCH and accepted by DFO-FPP to offset serious harm to fish will be adhered to.

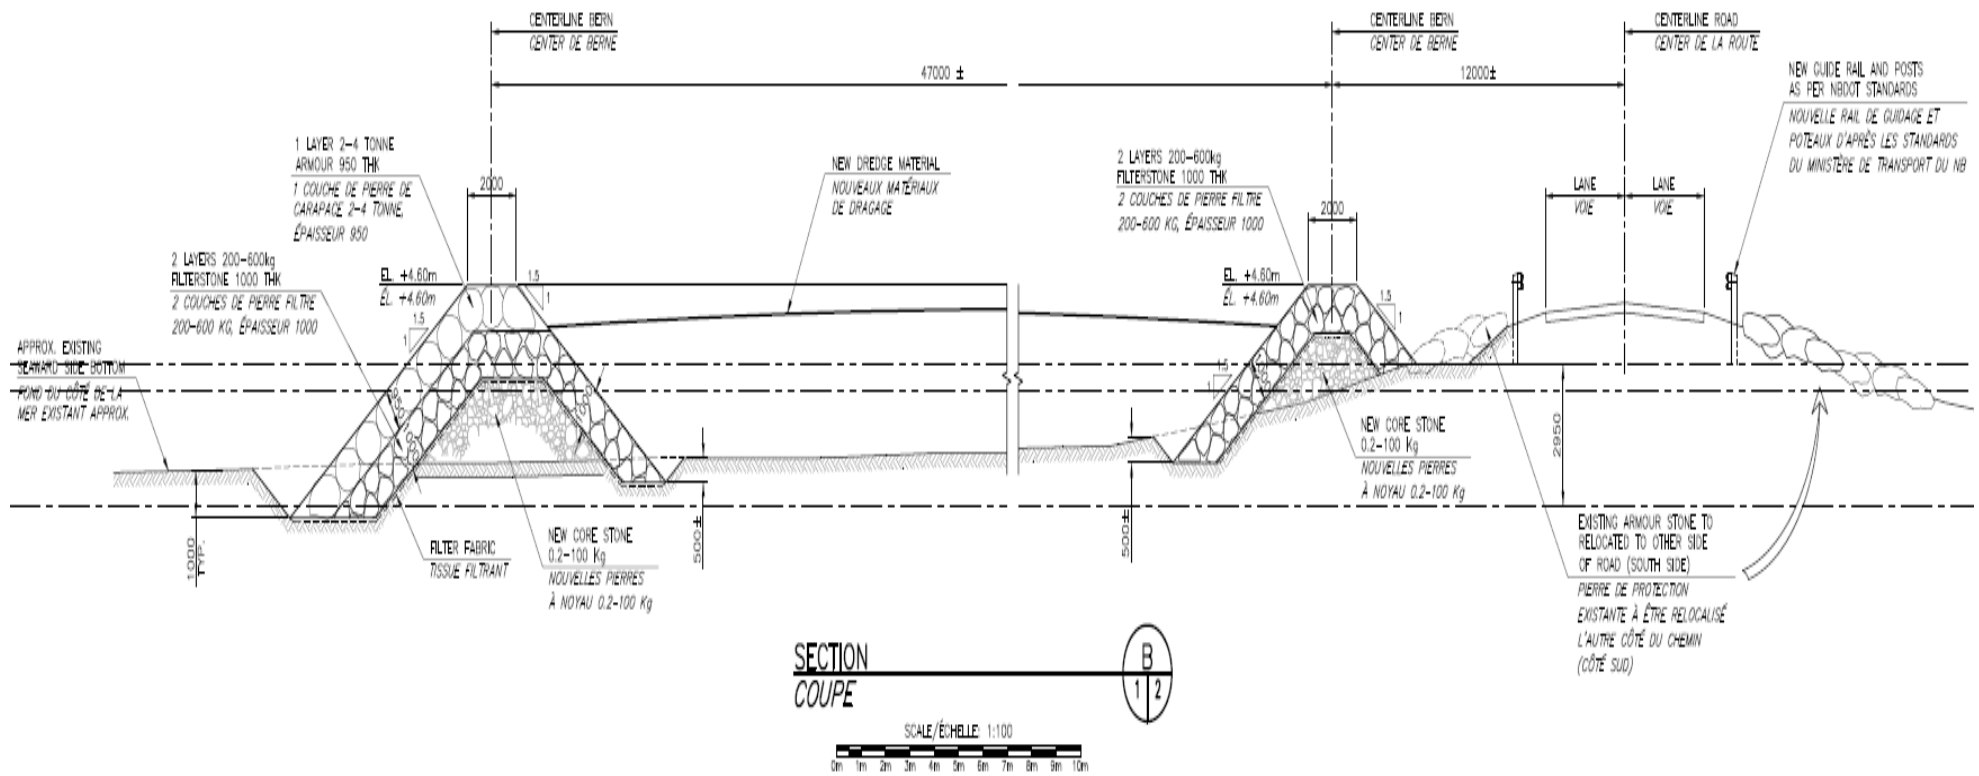
Figure 5: Cross-sectional view of proposed containment cell at New Mills DFO-SCH, Restigouche County, NB.

The project includes the construction of an approximately 120 meter by 55 meter containment cell with rubble mound walls. The walls will be constructed of core, filter and armour stone and three of the 4 walls will be located below the mean high tide mark. The cell will be located adjacent to the west of the causeway that accesses the harbour. A short access road (less than 5 meters) will connect the causeway road to the containment cell. Excavators will construct the base of the cell walls out from the shoreline, operating in the dry, and continue to build the walls up until the desired elevation is achieved. The construction material (rock) will be transported to the site via dump truck and dumped in place before being reworked to the desired position by the excavator. Total footprint of the cell will be approximately 6600m<sup>2</sup>.

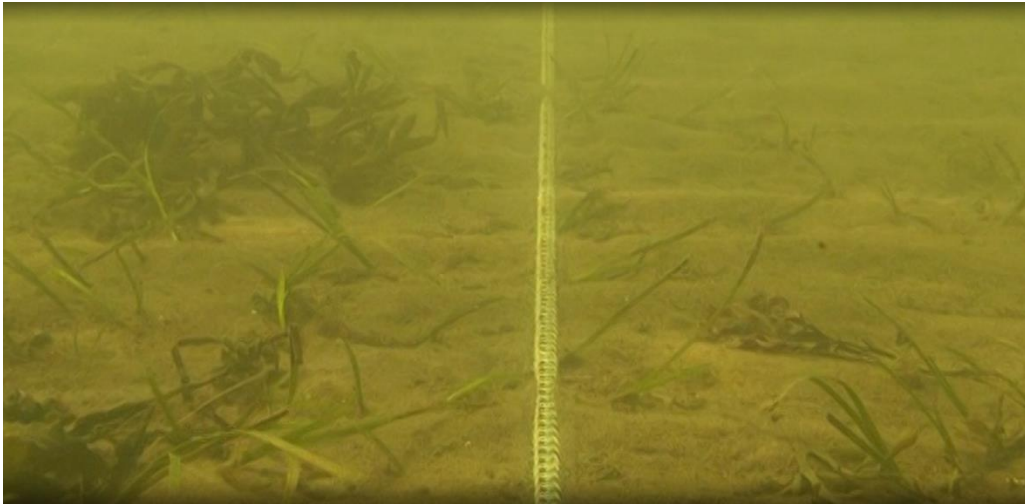
**Photo 1:** Typical sand substrate (pictured at 25m within Transect No. 6 on May 24, 2018).

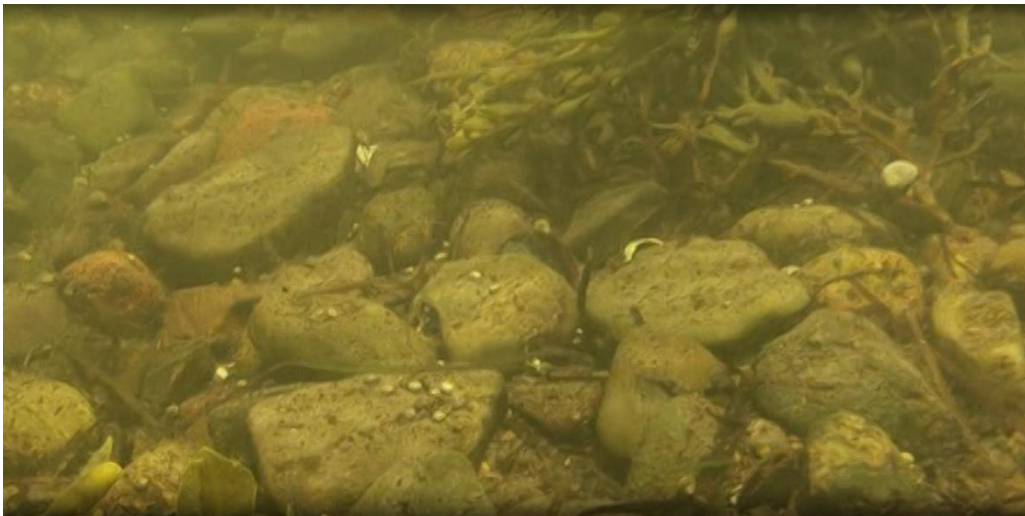
**Photo 2:** Typical rock substrate (pictured at 1m within Transect No. 5 on May 24, 2018).

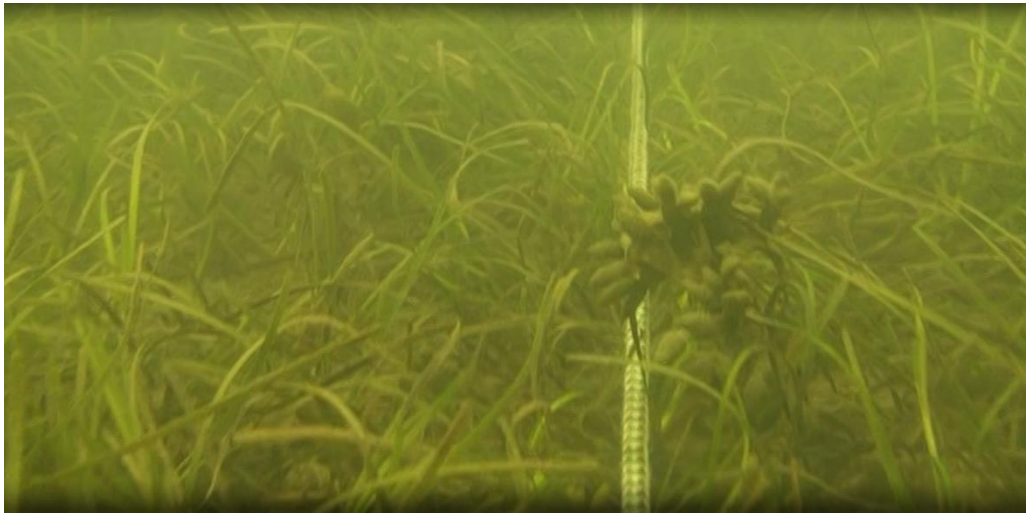
**Photo 3:** Dense live Eelgrass bed (pictured at 55m within Transect No. 3 on May 24, 2018).

- Bladderwrack (*Fucus sp.*): observed along the 0-10m and 40-60m segments (5% coverage).
- Rock weed (*Ascophyllum nodosum*): observed along the 10-25m and 50-60m segments (5% coverage).
- Brown algae (*Desmarestia sp.*): observed along the 0-5m and 40-50m segments (5% coverage).
- Irish Moss (*Chondrus crispus*): overserved along the 0-5m segment (5% coverage).
- Eelgrass (*Zostera marina*): observed along the 30-35m segments (10% coverage); 35-40m segments (40% coverage); and 40-60m segments (80% coverage).

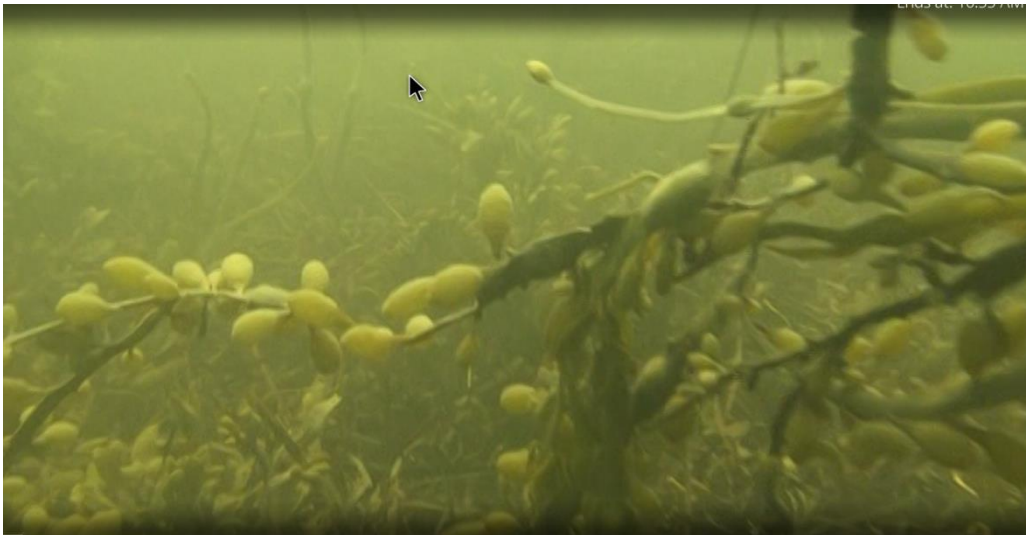
**Photo 4:** Typical Macrofloral life (pictured at 2m within Transect No. 1 on May 24, 2018).

- Bladderwrack (*Fucus sp.*): observed along the 0-10m segments (25% coverage); and the 10-40m, 45-50m, 60-65m and 75-95m segments (5% coverage).
- Rock weed (*Ascophyllum nodosum*): observed along the 0-10m segments (15% coverage); and the 10-15m, 20-25m, 30-35m and 60-65m segments (5% coverage).
- Kelp (*Laminaria saccharina*): observed along the 0-5m segment (10% coverage).
- Brown algae (*Desmarestia sp.*): observed along the 0-10m segments (25% coverage); 10-15m segment (10% coverage); and 15-40m, 75-80m, and 85-100m segments (5% coverage).
- Irish Moss (*Chondrus crispus*): overserved along the 0-35m segments (5% coverage).
- Eelgrass (*Zostera marina*): observed along the 55-65m segments (5% coverage); 65-90m segments (20% coverage); and 90-100m segments (30% coverage).
