**Registration document**  
**Environmental Impact Assessment**  
Victory Baptist Fellowship Development

Projet n° 20-02  
June 2020

South Esk Miramichi Victory Living want to develop four (4) apartment buildings for senior citizens to meet the growing need for this type of housing. The project included the development of new wells, installation of septic systems, drainage of surface water, construction of a new public street and bushing of existing trees.

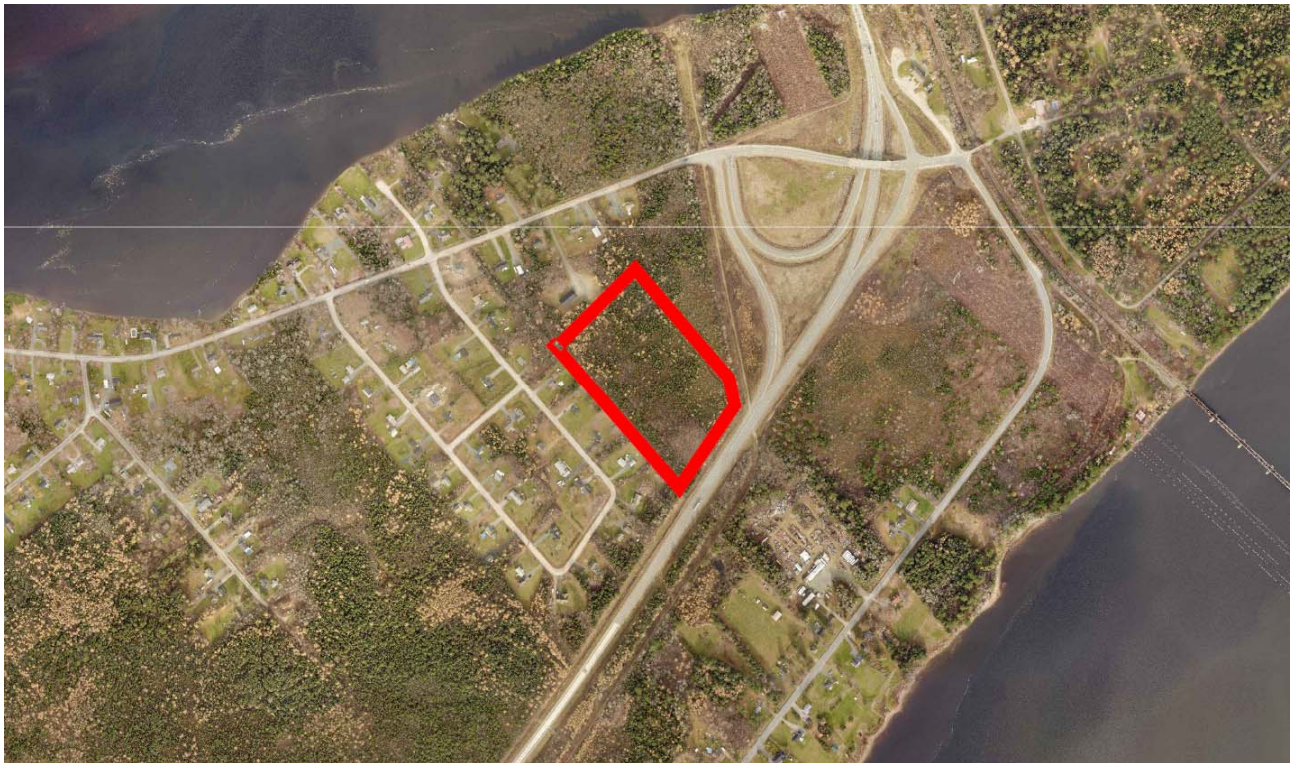
**Figure 2. Recent aerial view**

It is also possible to perceive on the aerial photograph of 1963 that the residential development has started and that the roads are already present. The comparison of the aerial photographs also shows that the study area has not undergone any major change since 1995. It is possible to observe on the 1995 aerial photograph that the residential area adjacent to the subject property and the exit from highway are as they are today. Figure 2 shows a recent aerial view of the subject property and adjacent properties.

In order to determine the historical uses of the subject property and the adjacent lands, aerial photographs from 1965, 1975, 1983, 1995 and 2005 (see Appendice B) were obtained through Service New Brunswick. These aerial photos show that the subject property and adjacent lands were used for residential activities and motor vehicles traffic.

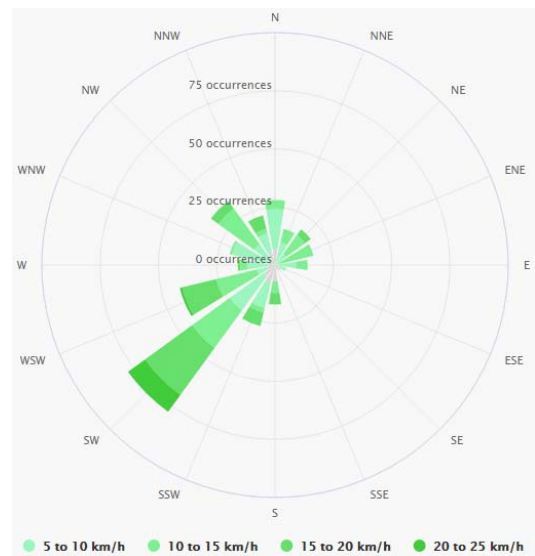
Figure 3. Wind rose (source : meteoblue)

As per Figure 3, the winds are predominantly from the southwest and are blowing away any atmospheric emissions to the Gulf of St Lawrence. There are no major industrial sources of emissions located near the subject property since the closure of the former Miramichi Pulp and Paper Mill approximately ten (10) years ago. The nearest industrial emission source is located approximately 9.5 km northeast. The air quality is considered representative of a rural community since the main sources of atmospheric emissions come from home activities, vehicles, trains and boat traffic.

It can therefore be concluded that the air quality of the region is good due to the absence of industrial emitters and the direction of the prevailing winds.

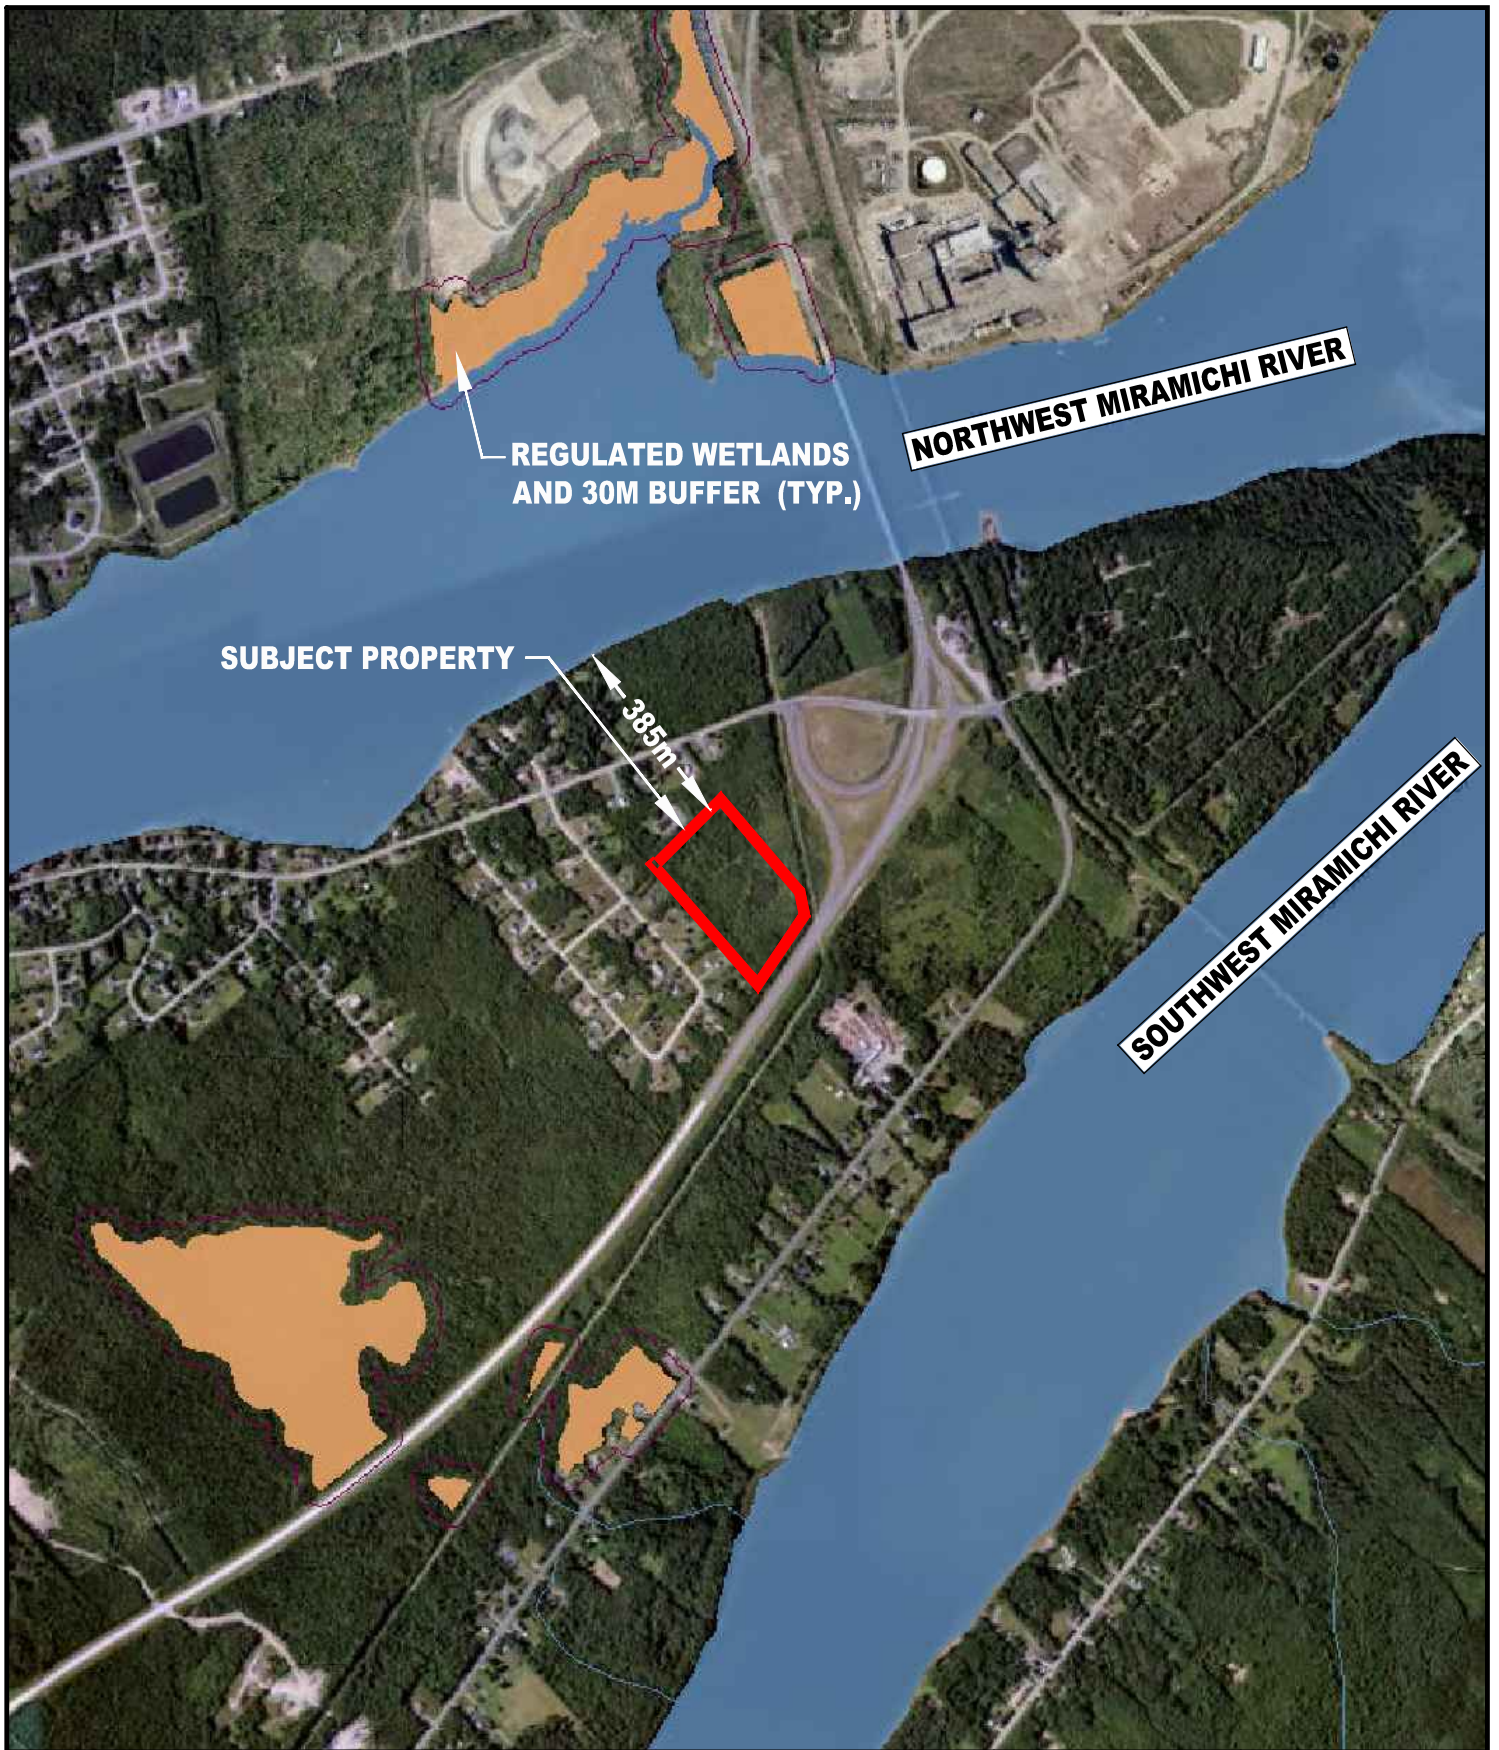
A consultation of the DELG online "WAWA Reference Map" confirmed that there is no suspected wetland within 30m of the subject property as shown on Figure 4. The closest watercourse, the Northwest Miramichi River, is located 385m northeast. The Northwest Miramichi River flows into the Miramichi River, which then flows into the Miramichi Bay via the Miramichi Inner Bay.

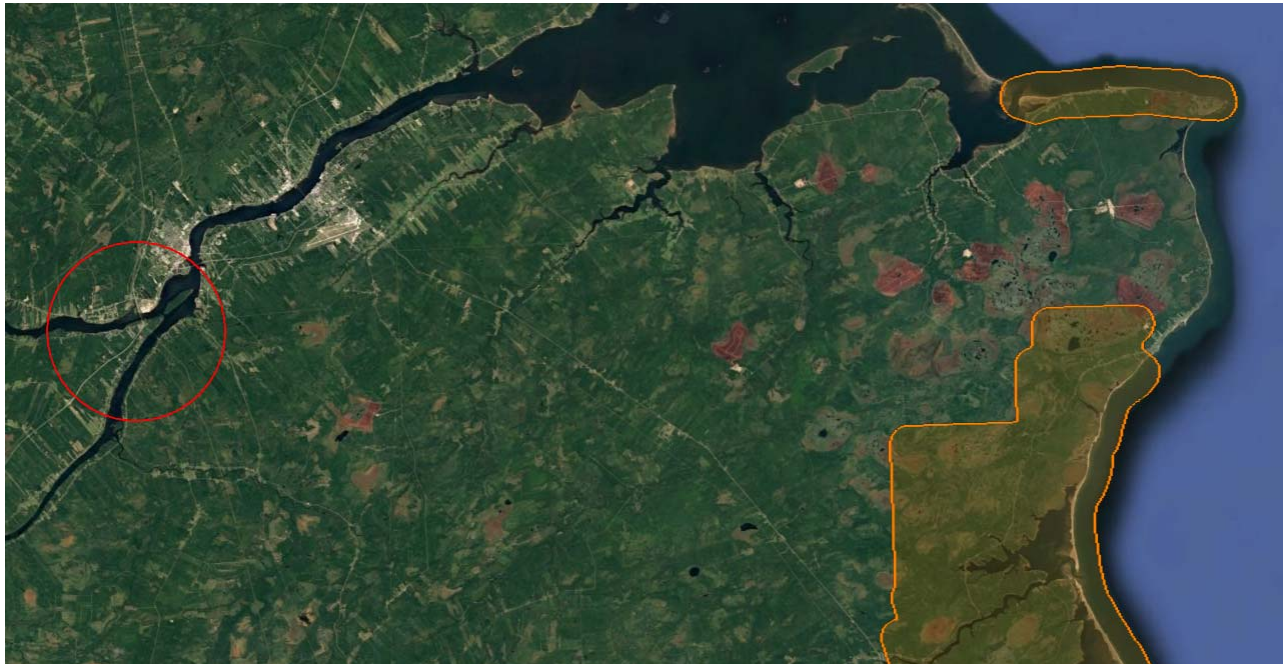
Figure 5. IBA within a 5km radius from the study site

A search in the Canada's Important Bird and Biodiversity Areas (IBA) online directory confirmed that there is no IBA within a 5km radius of the study area as shown in red on Figure 5.

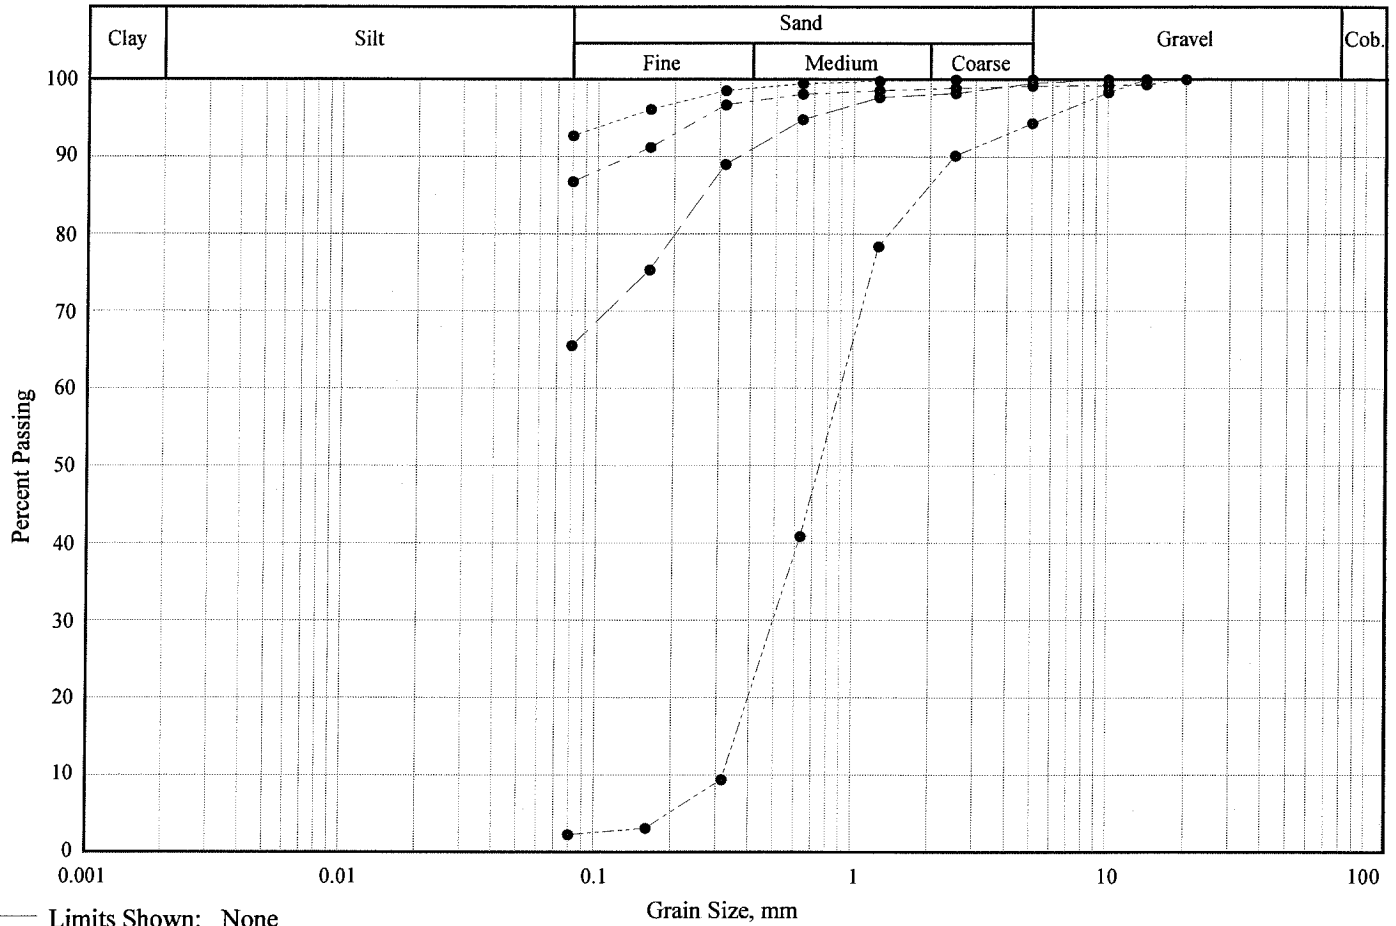
# Soils Grading Chart

Line Symbol	Description	Borehole/ Test Pit	Sample Number	Depth	% Cob.+ Gravel	% Sand	% Silt	% Clay	Date Sampled
-----	grabbed sample	3	2	3.0	0.5	34.0	65.5		03/01/15
-----	GRABBED SAMPLE	3	1	2.3	0.0	7.3	92.7		03/01/15
-----	grabbed sample	1	2	1.5	0.8	12.4	86.8		03/01/15
-----	grabbed sample	1	1	0.6	5.7	92.0	2.3		03/01/15

Line Symbol	Sample Description	D <sub>10</sub>	D <sub>15</sub>	D <sub>85</sub>	% 5-75µm
-----	Sandy silt , trace gravel	0.0000	0.0000	0.2584	---
-----	Silt , trace sand	0.0000	0.0000	0.0000	---
-----	Silt , some sand , trace gravel	0.0000	0.0000	0.0000	---
-----	Sand , trace gravel, trace silt	0.3191	0.3564	1.8474	---

The surface grade is covered in all test pits with loose, coarse to fine sand which thickness varied (between 300 and 800 mm thick). A sieve analysis was carried out on a recovered sample from test pit 1 and 5.7% gravel, 92% sand and 2.3% silt was found.

The sand layer is underlain in all test pit by a layer of light reddish brown silt, trace of sand. This layer is hard with pocket penetrometer readings varying between 3.0 and 4.5 ton/ft<sup>2</sup> and varied in thickness between 0.8 and 1.8 m thick. Two sieve analysis were carried out and between 0 and 0.8% gravel, 7.3 and 12.4% sand and 86.8 and 92.7% silt were found.

A layer of firm sandy silt, trace gravel was encountered in all test pits below the silt layer with pocket penetrometer readings varying between 2.0 and 2.5 ton/ft<sup>2</sup>. A sieve analysis was carried out and 0.5 % gravel, 34.0 % sand and 65.5 % silt were found.

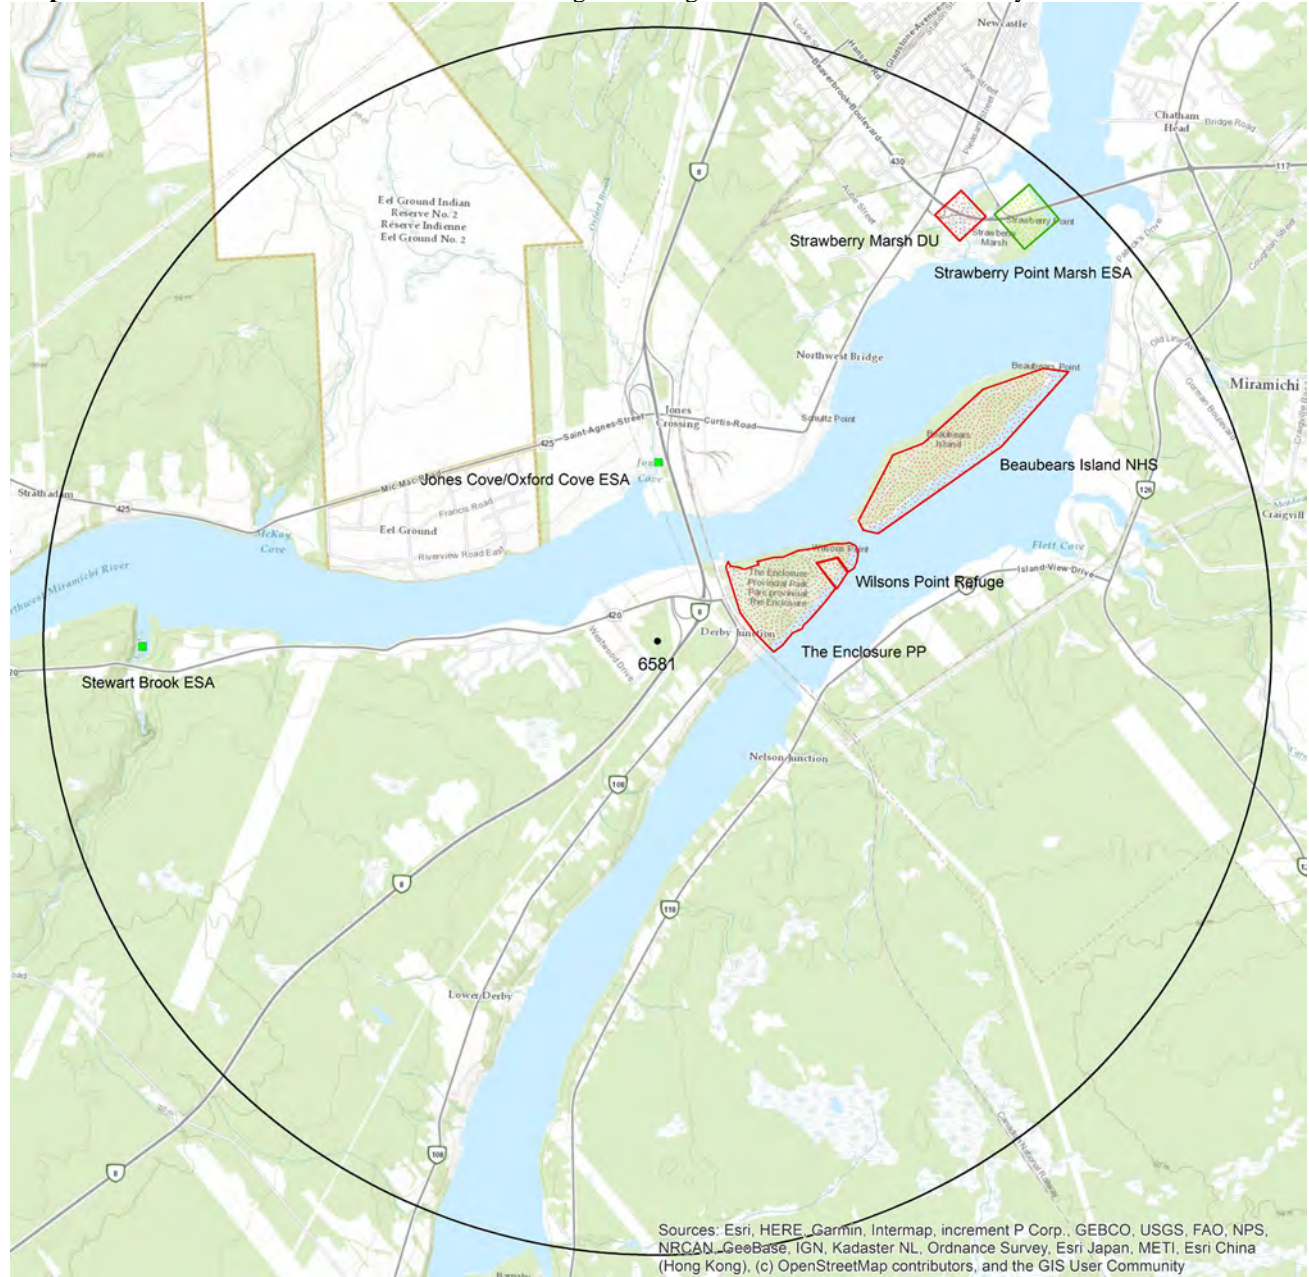
**Map 3:** Boundaries and/or locations of known Managed and Significant Areas within the study area.

The GIS scan identified 3 biologically significant sites in the vicinity of the study area (Map 3 and attached file: \*sa\*.xls).
