**Draft Environmental Impact
Assessment**

Homes by the Bay Residential Development
Pocologan, NB

**Subject: Draft Environmental Impact Assessment
Homes by the Bay Residential Development, Pocologan, NB**

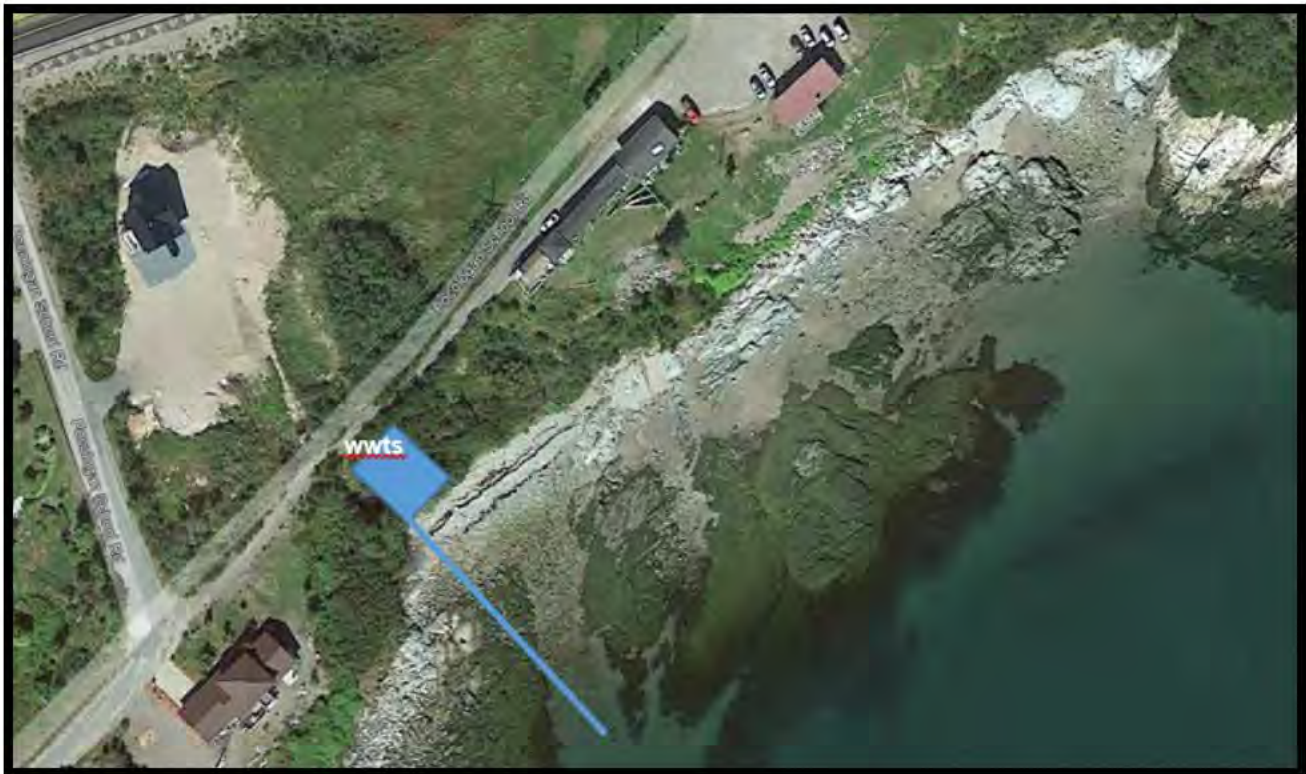
Figure E: Approximate Discharge Pipe Location

The actual length of the pipe and location of the collar will be determined through the detailed design process, and will depend on the exact location and the depth of the water at the site.

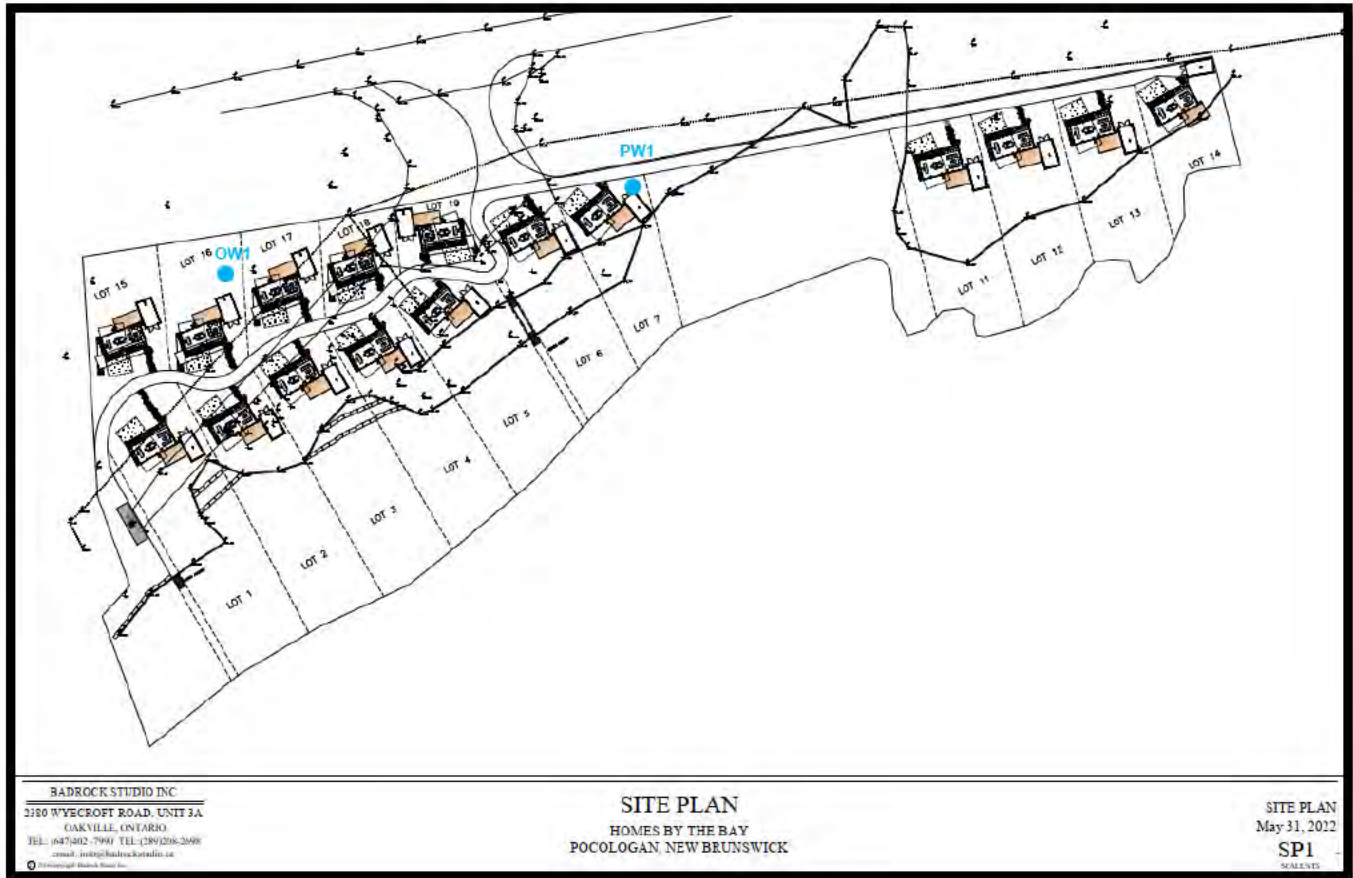
Figure B: Proposed Subdivision Layout and Proposed Well Locations

The proposed observation well (OW1) will be located on PID 15206840 (Lat. 45.128368 Long. -66.572922) (proposed Lot 16 on Figure B), and the proposed pumping well PW1 will be located on PID 01212406 (Lat. 45.128531 Long. -66.57126) (proposed Lot 7 on Figure B).

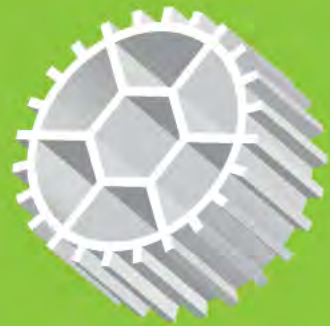
Self-cleaning media at the core of the process

The core of the process is the specially designed biofilm carrier media made from High-Density Polyethylene (HDPE). The media provides a high surface area for optimal biofilm growth to treat the wastewater. The aeration system completely mixes the media inside the biological reactor providing access to oxygen. The media design and mixing process ensures that the media is self-cleaning, will not clog, and does not require replacement.

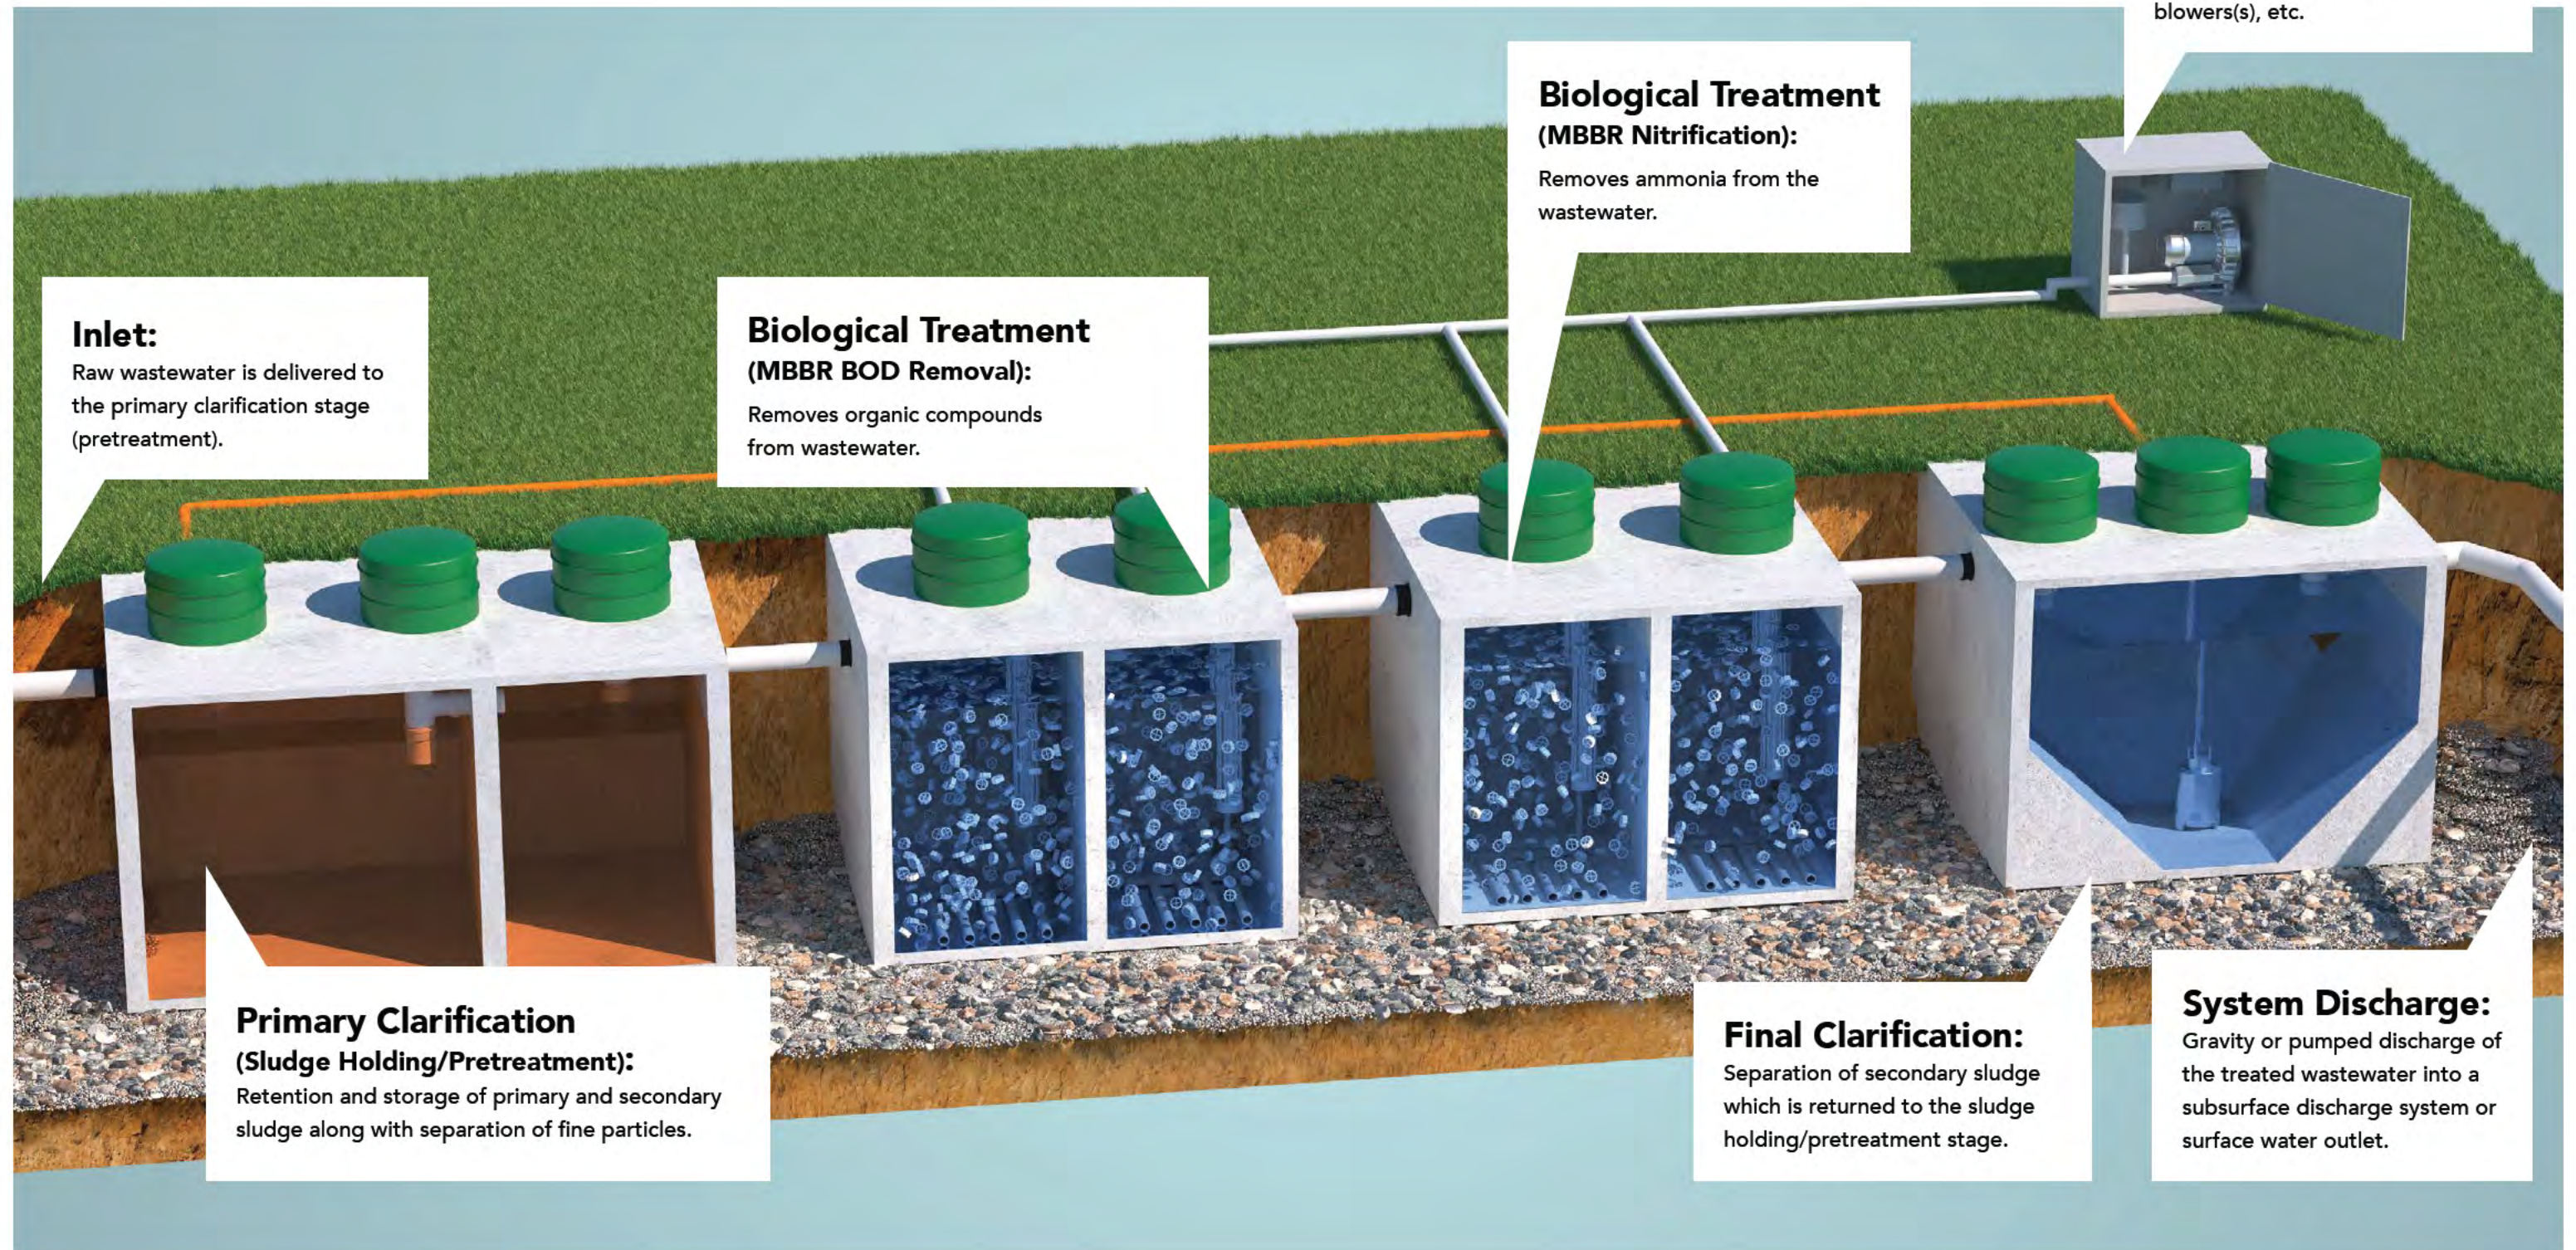
RH20[®] Treatment Process

Inlet:
Raw wastewater is delivered to the primary clarification stage (pretreatment).

Biological Treatment (MBBR BOD Removal):
Removes organic compounds from wastewater.

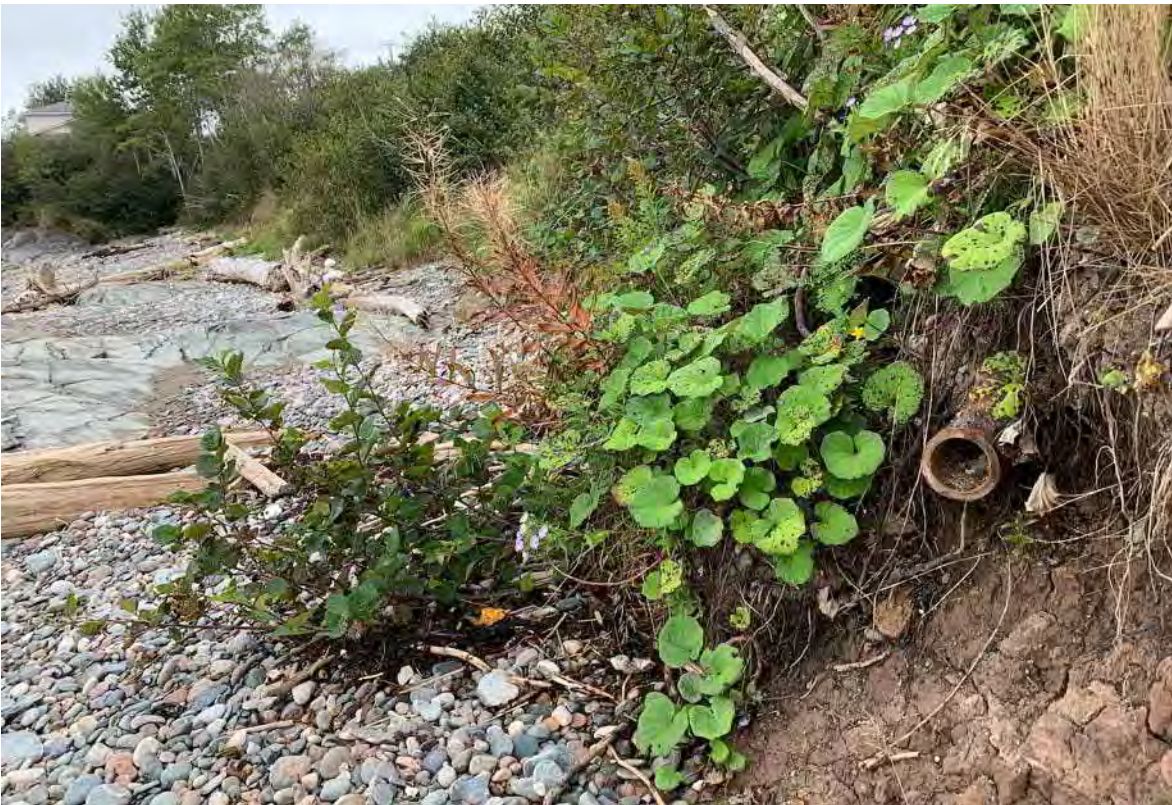
Figure 27. Massive clay bed eroding at waypoint 171, facing east.

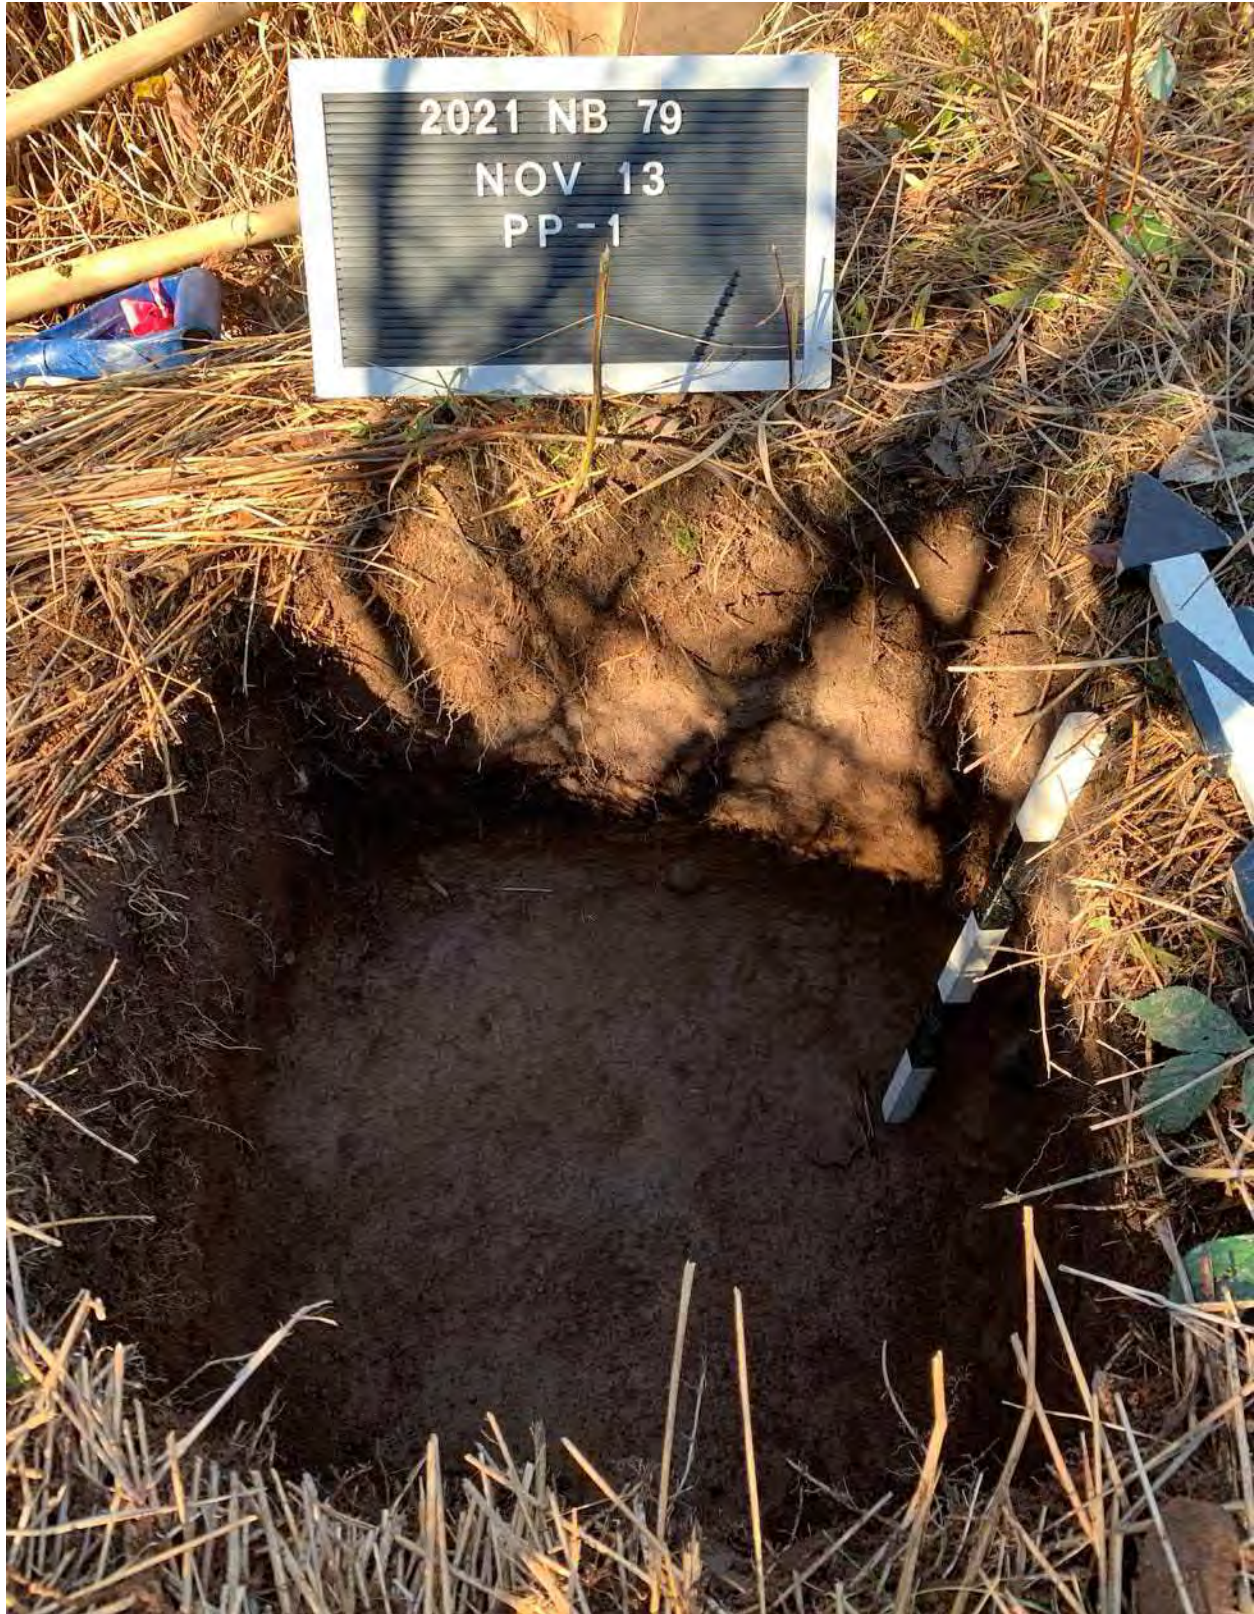
Figure 48. Mitigation model for project development area (PDA), if construction plans include sub-surface disturbance. Red outline is 50 m buffer zone, requiring 5 m testing grid for Standard Test Pits (STPs). PDA is in east and west sections. Blue line is surface inspection GPS tracks. Green lines enclose areas where test excavation is not feasible/warranted: old road = 1061 sq m; fill SW = 425 sq m; restaurant and parking lot = 1721 sq m, total 3207 sq m. Pocologan West = 6391 sq m; Pocologan East = 5412 m; Total = 11,803 – 3207 = 8596 sq m testable on 5 m grid. 8596 sq m divided by 25 sq m (5 m x 5 m grid unit) = 343 STPs plus about 7 on 10 m grid = 350 STPs total estimate.

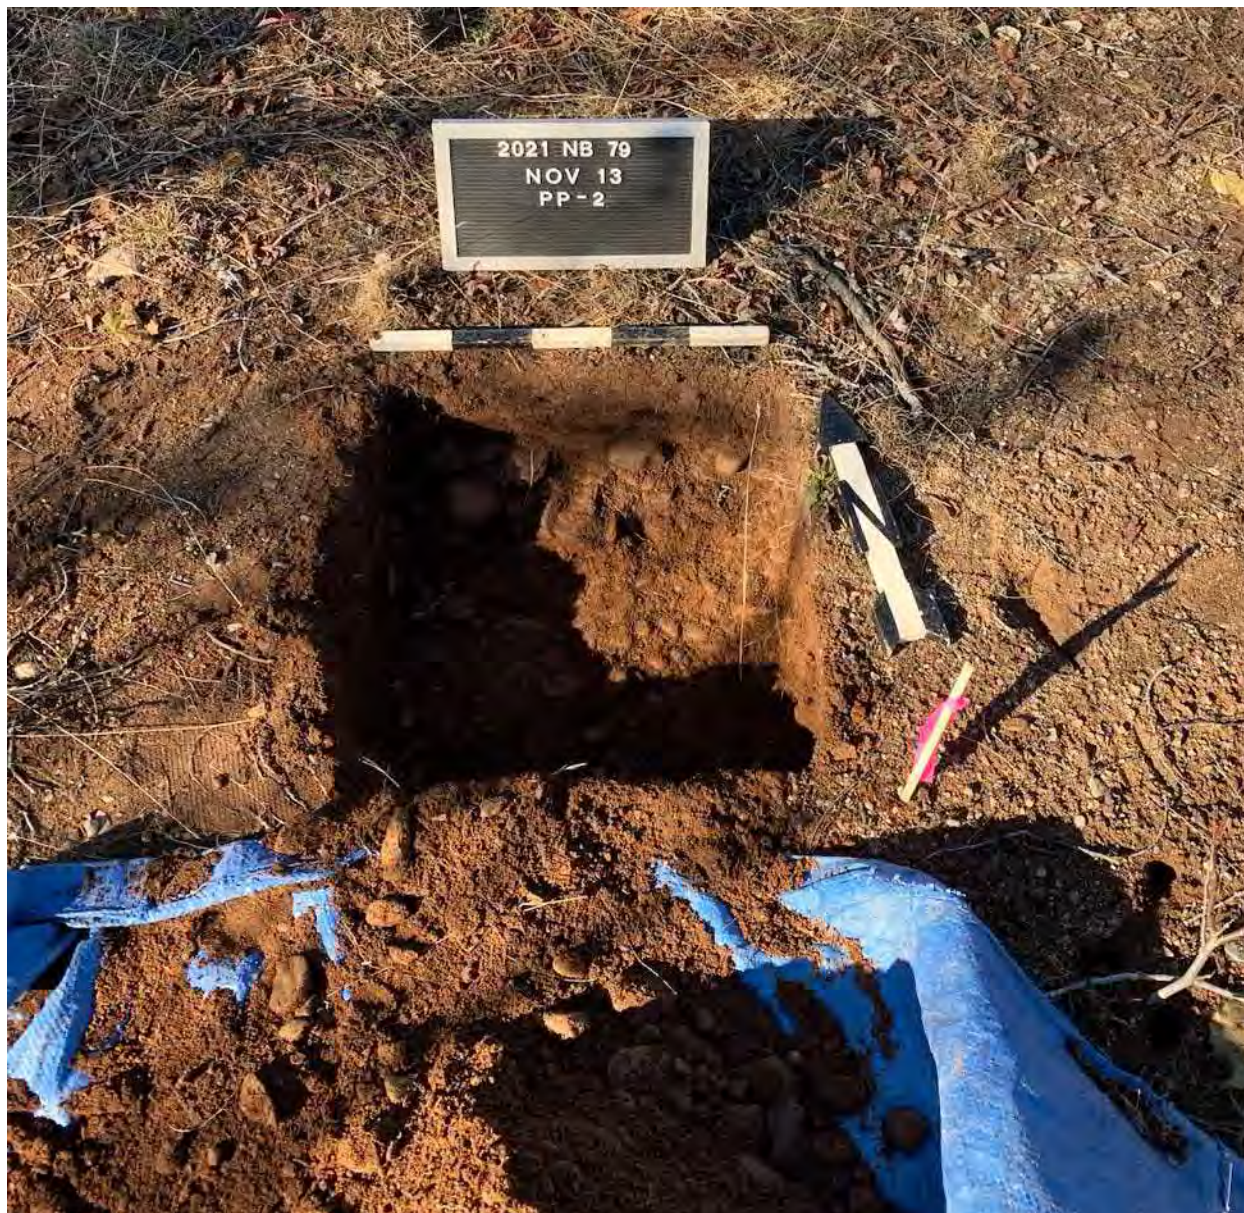
Figure 50. STP PP-1, archaeological bottom at clay layer, 40 to 50 cm below surface

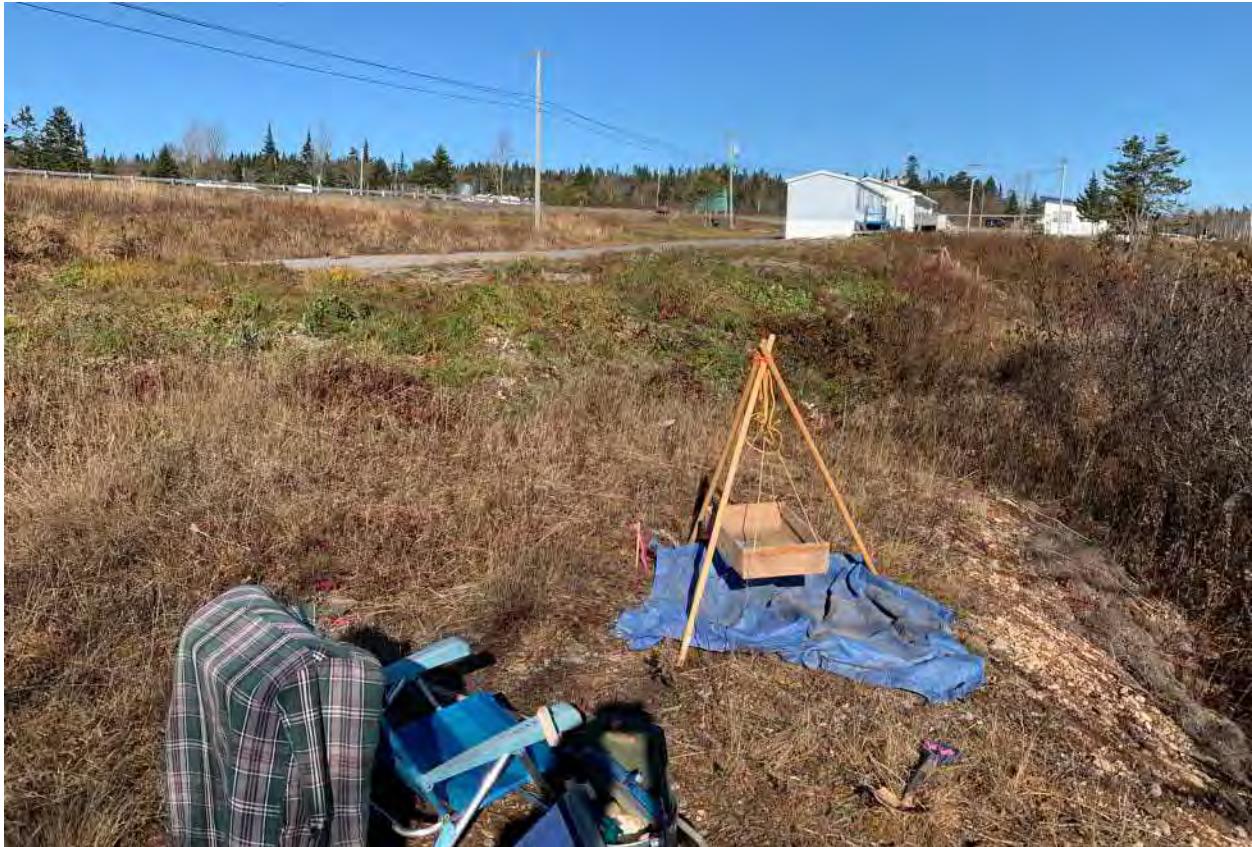
Figure 51. Shovel test pit at waypoint 191. Dense, compacted stony layer at 10 cm below surface.

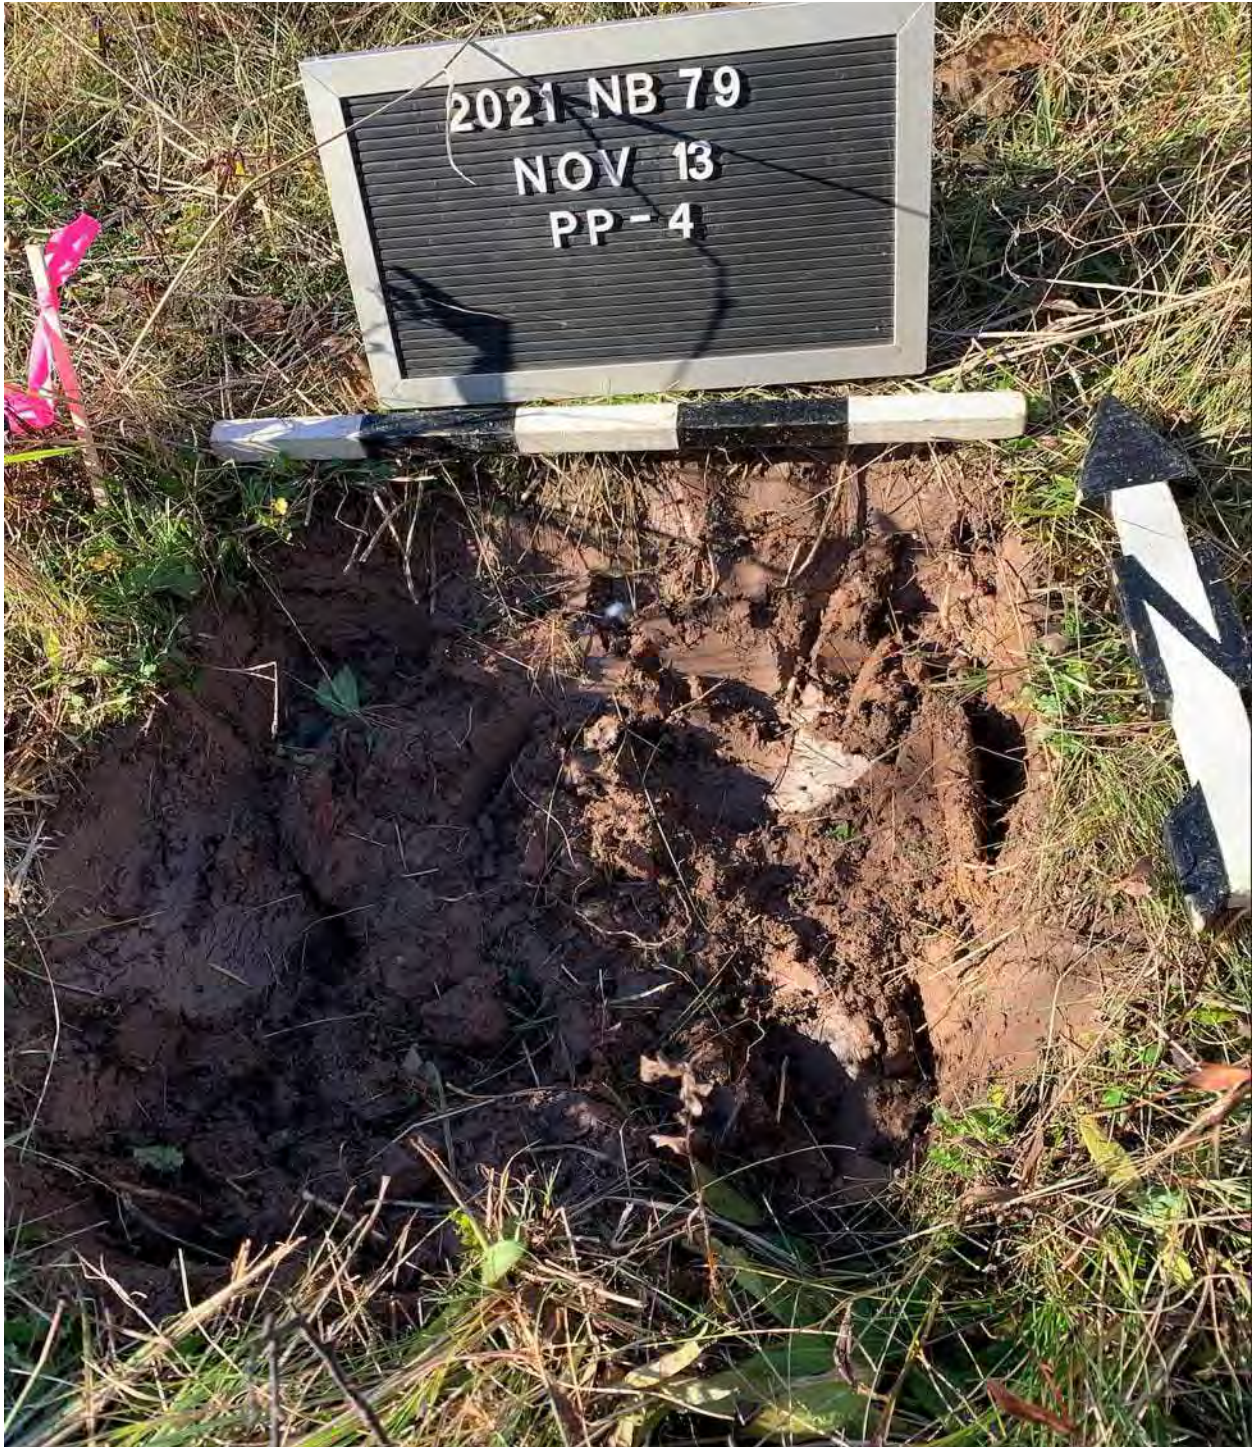
Figure 53. Profile of PP-3 at waypoint 193. Archaeological bottom is very compact sand with pebble inclusions.

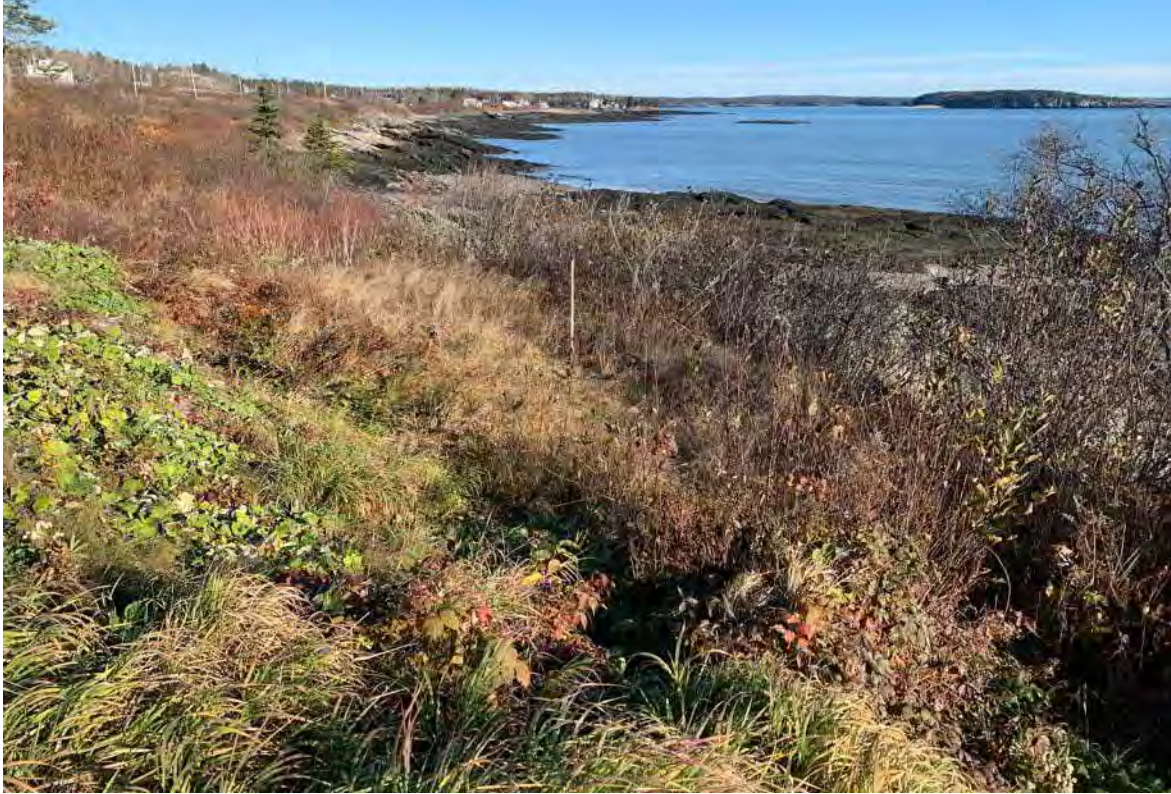
Figure 54. Pure red clay immediately beneath sod in PP-4, at waypoint 193.

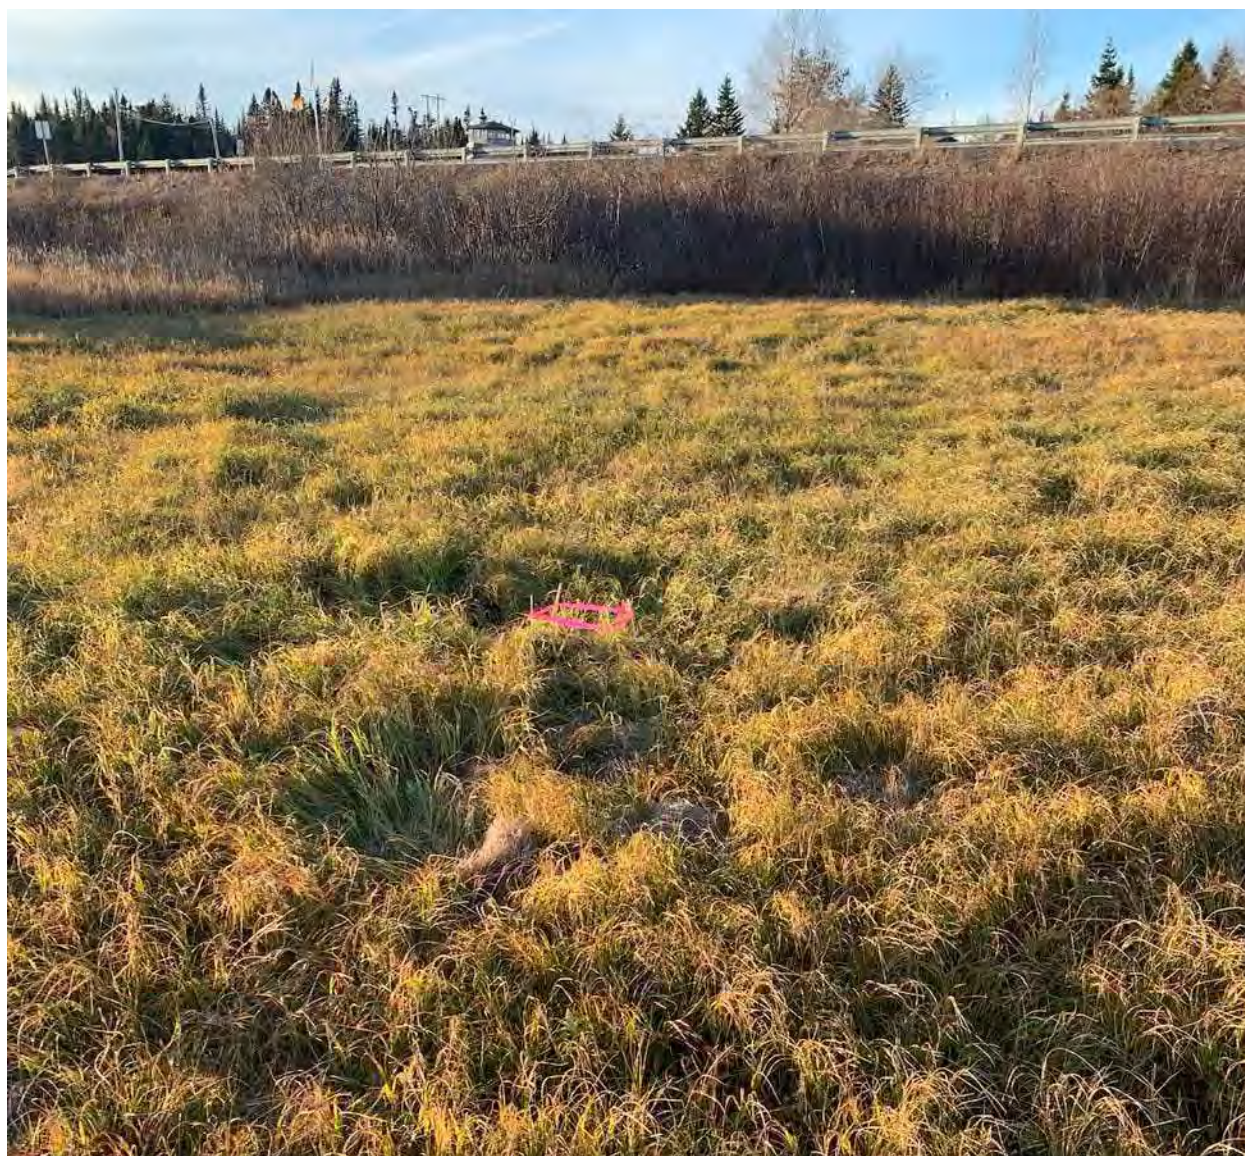
Figure 58. STP PP-5 located at waypoint 203. Clay immediately under sod.
