Parlee Beach Provincial Park Channel Assessment Study & Report

NB Department of Tourism, Heritage and Culture

TECHNICAL REPORT

February 14, 2019

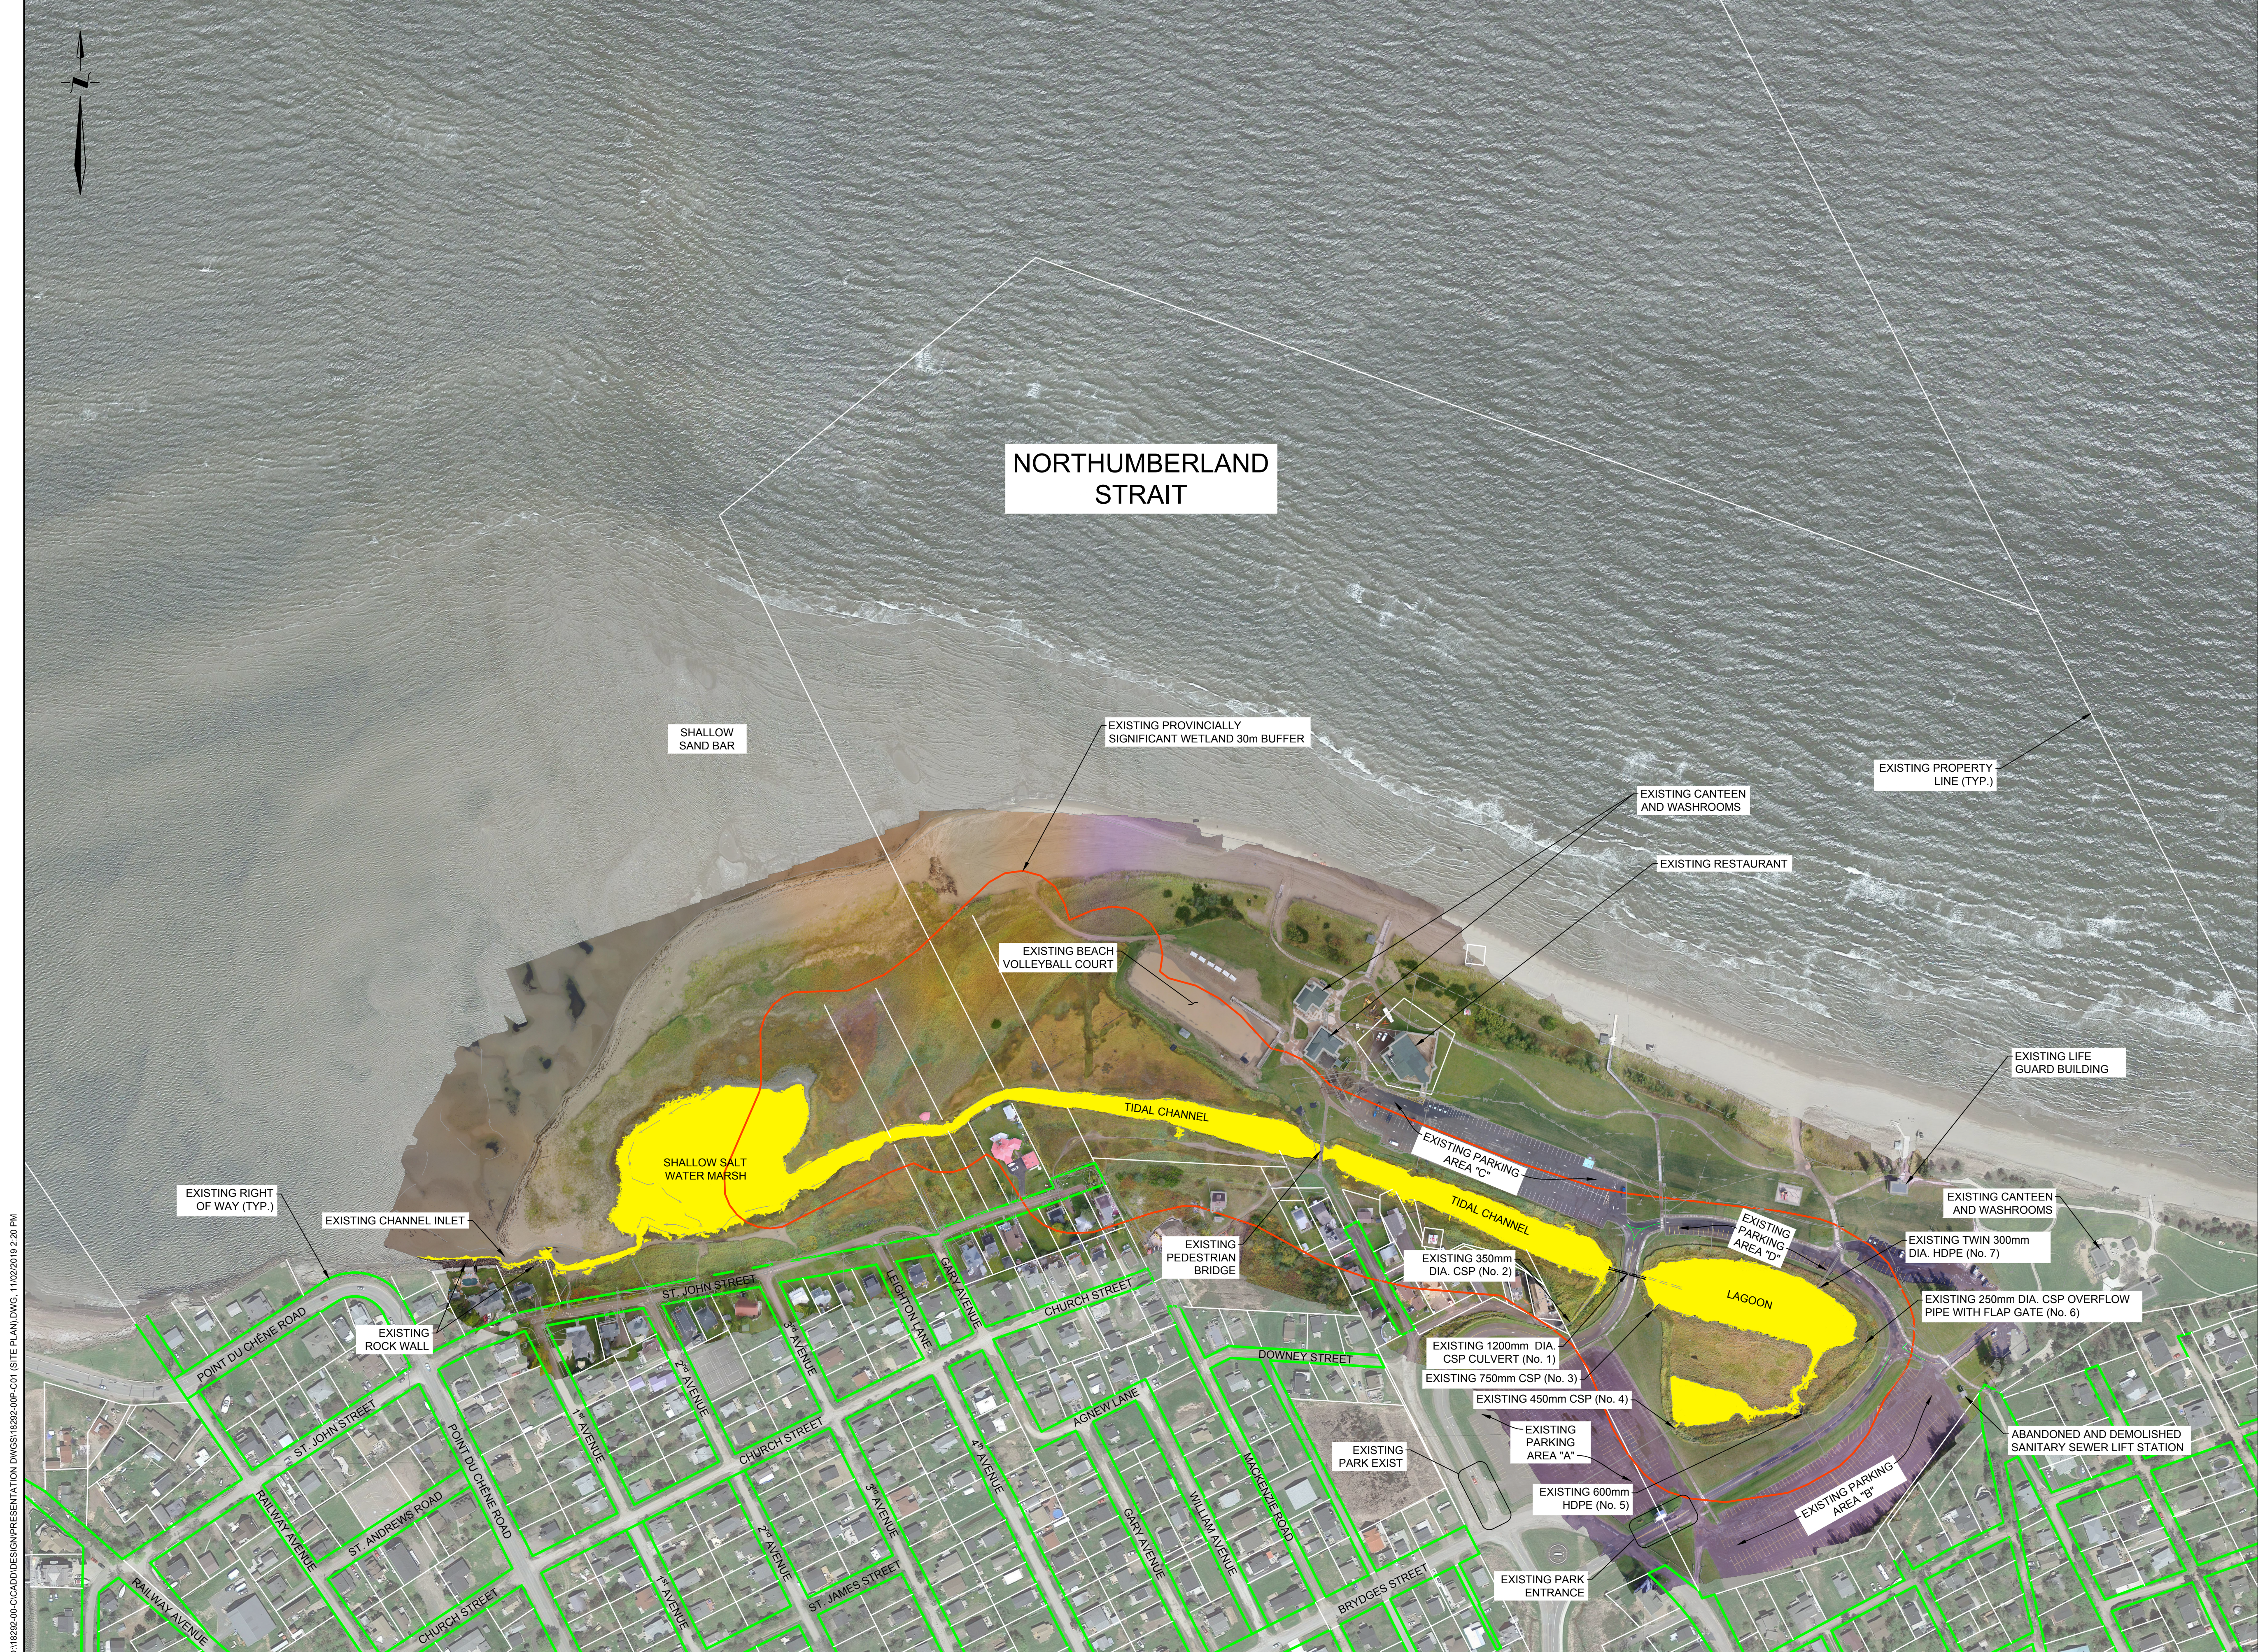
- The closest house is approximately 5 metres away from the channel, well within the Provincially significant Wetland as well as other grandfathered structures;
- A culvert divides the lagoon and the channel and allows the vehicles to exit the parking area on the north side of the channel and lagoon;
- There are pipes discharging to the lagoon and channel;
- The channel is crossed by a pedestrian bridge;
- The natural marsh vegetation buffer around the channel and the lagoon is an average six (6) metres with as little as two (2) metres at some places.

Crandall completed a field observation of the channel edge near all existing homes and did not locate any sewer services discharging directly to the channel. Crandall also reviewed the record drawings provided by the Greater Shediac Sewerage Commission and found that all residences that border the channel have a service connection to the sanitary sewer system. All sanitary sewer piping can be seen on **Drawing 18292-00P-C01**.

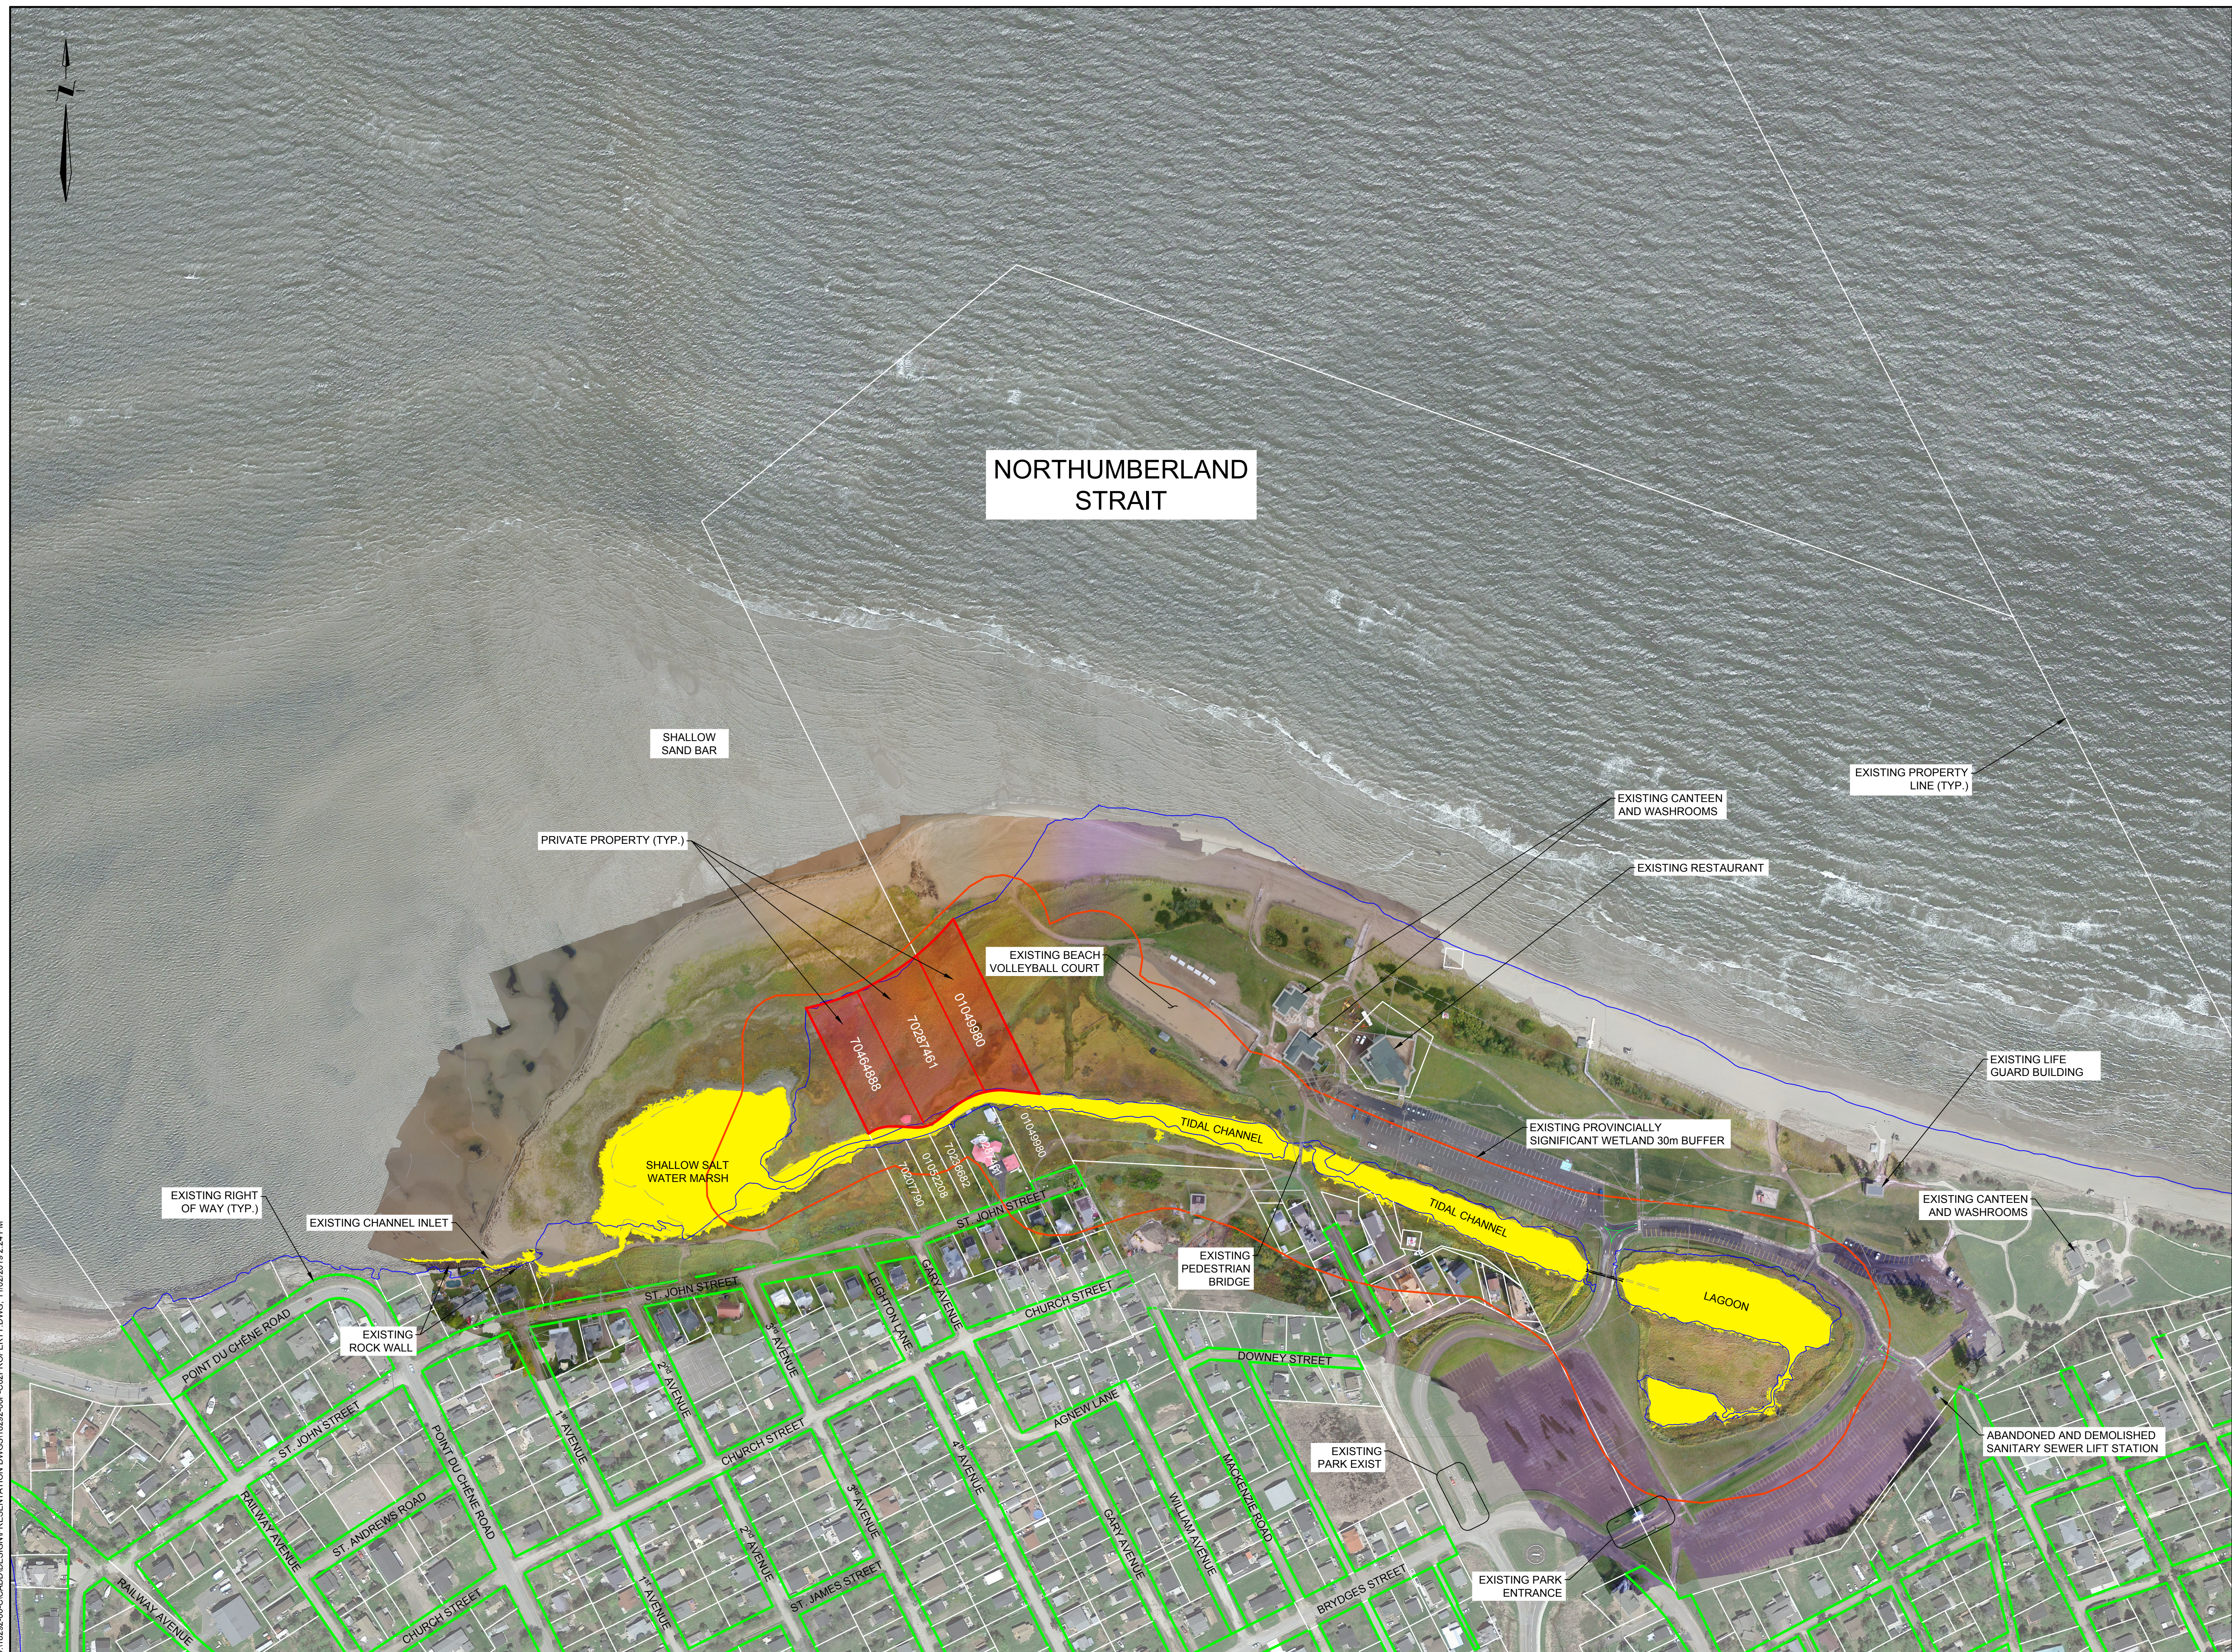
A land ownership review was completed by MacAulay Surveys Ltd. of Moncton, NB. Presently, there are three parcels of private property north of St. John Street that cross the channel and end at the Northumberland Strait high-water mark as shown in red on the Private Property Easement Identification **Drawing 18292-00P-C02**. Records from each parcel (PID 70464888, 70287461 and 01049980) from the Service New Brunswick Property Data Base do not show or describe any easement in place through these properties. Further legal investigation of these properties is recommended to confirm any early easements that may have been in place from previous owners.

As a result, there does not appear to be legal access along the high-water mark from Parlee Beach property to the westernmost point of the beach (i.e. channel inlet). However, the License of Occupation Application may be issued to allow work activity to use crown land (Provincial Parks) below the high-water mark as a legal agreement authorizing a non-exclusive use of crown land for a specific period under certain conditions.

- 1. Consider obtaining an easement through the private properties.*
- 2. A License of Occupation should be registered so that all channel maintenance activities can be performed below the high-water mark.*

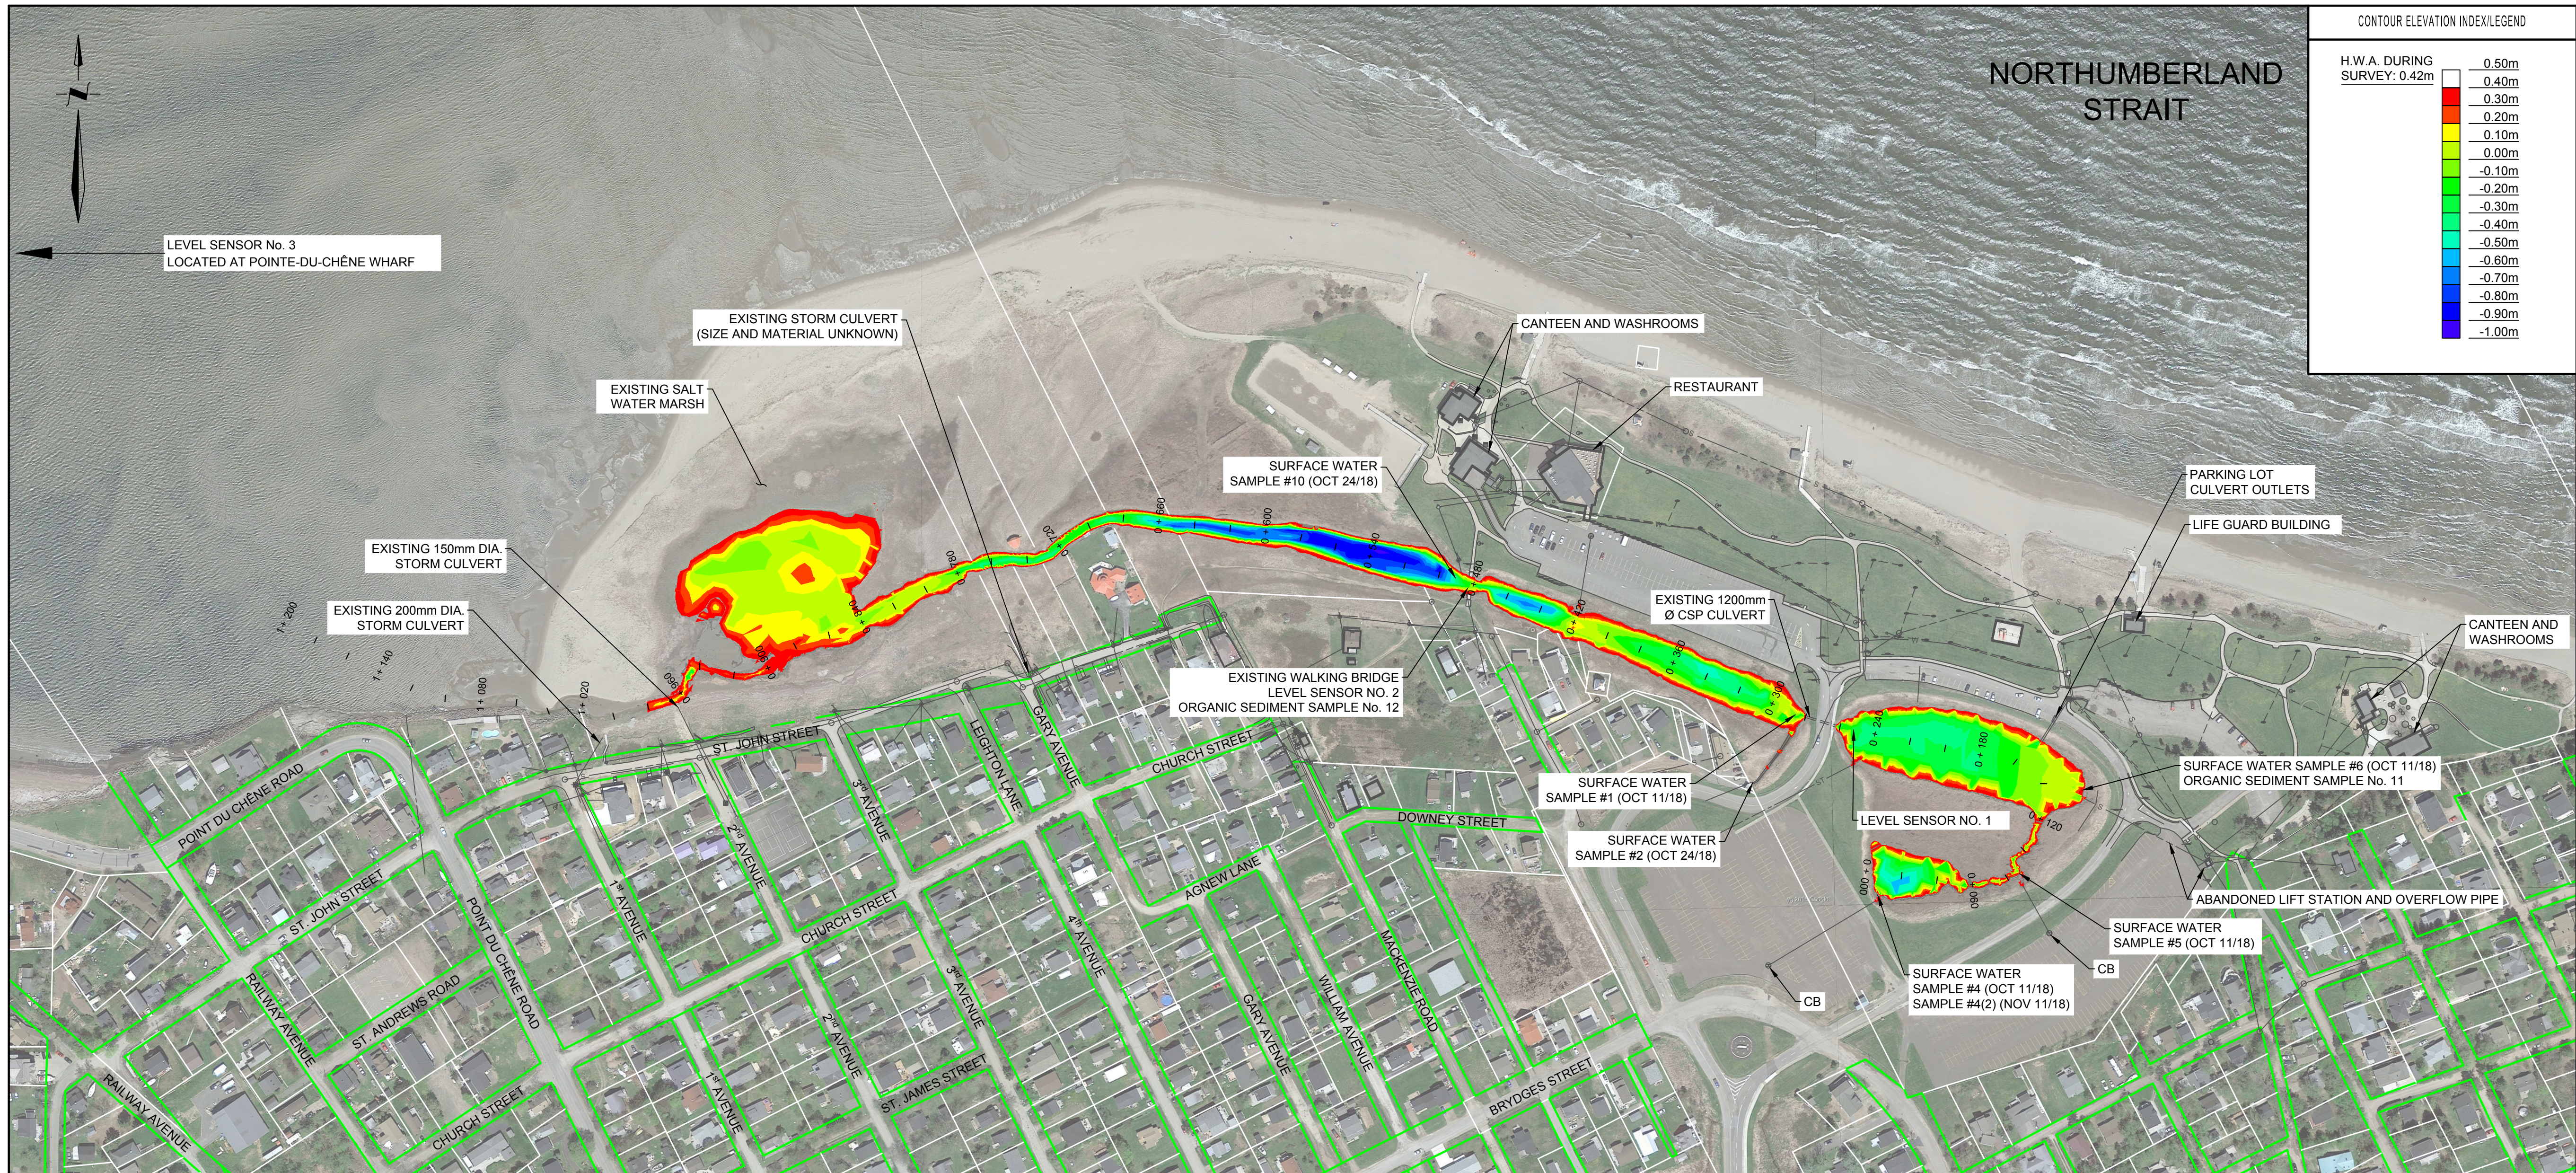
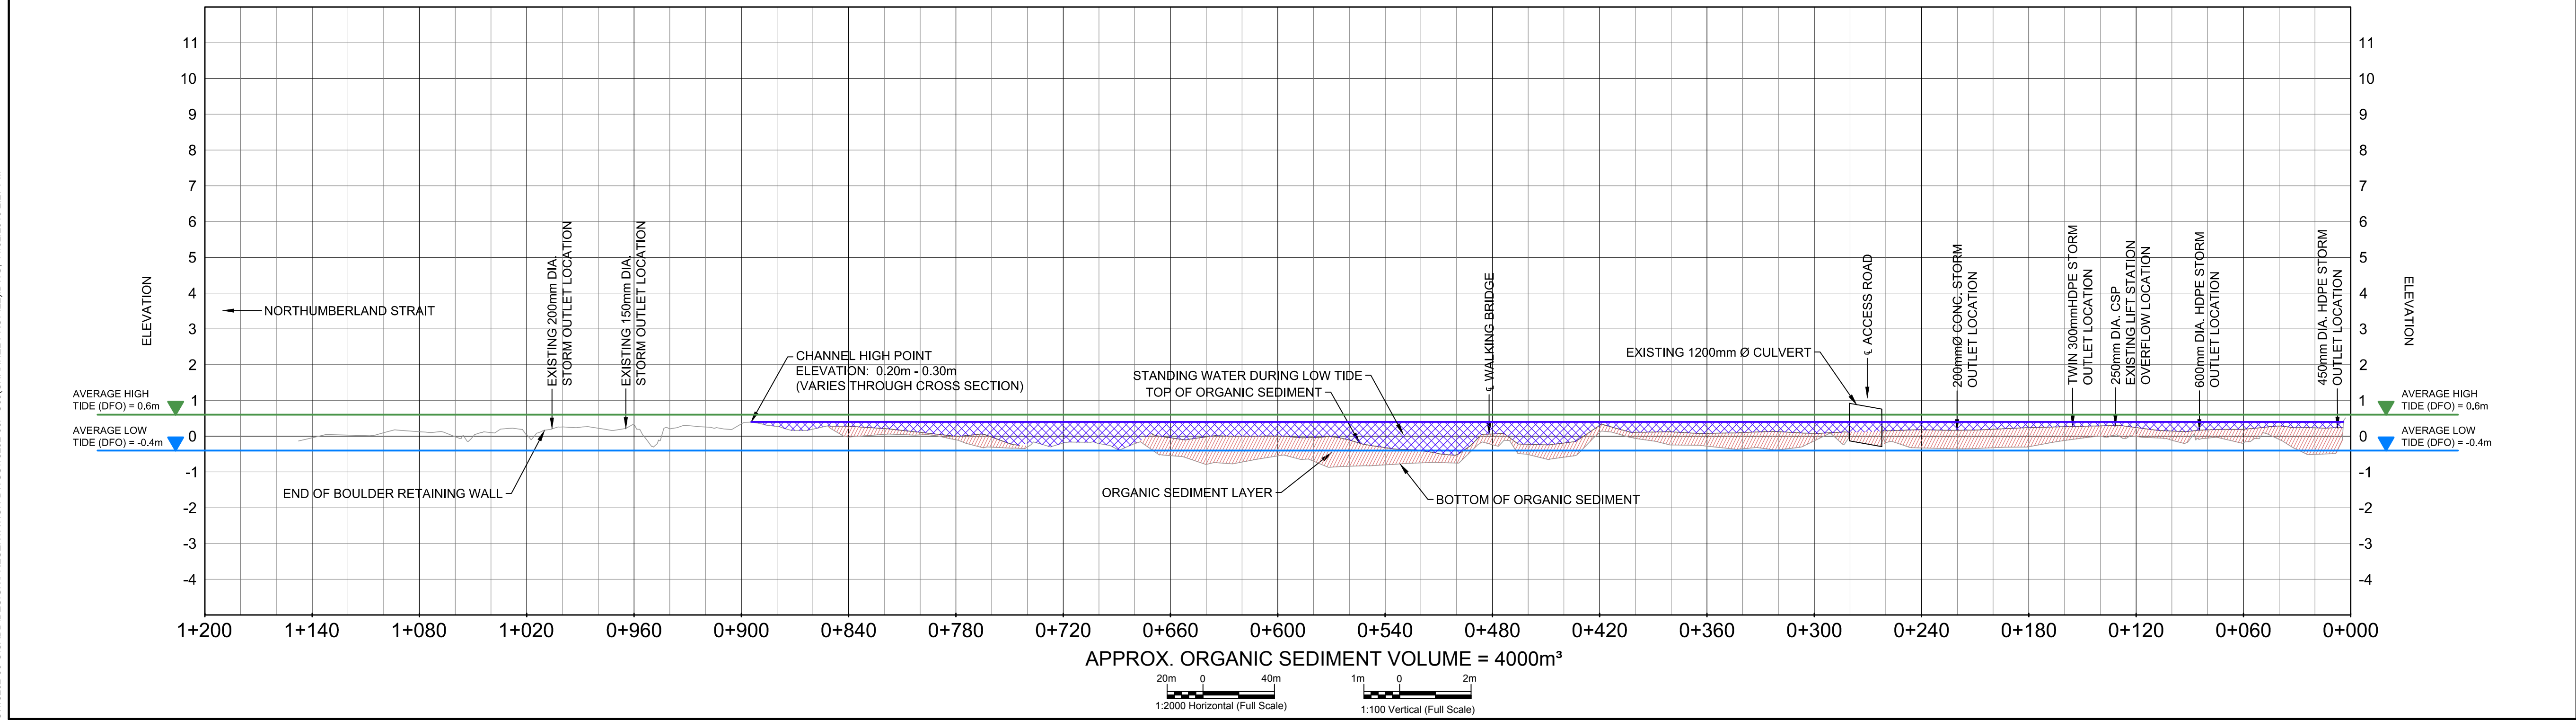
Drawing No.: 18292-00P-C03

There is a black organic sediment layer in areas of the lagoon and channel bottom, shown on the profile of **Drawing 18292-00P-C03**.

Crandall determined the sediment thickness to range from 0.0 m to 0.90m in the channel and lagoon. The total volume of sediment in the channel and lagoon was calculated to be approximately **4,000 m³** based on sludge gun depth measurements, bathymetry and GPS survey cross sections.

Sampling results identified four (4) out of the eight (8) water samples collected to contain E. coli counts higher than the Guidelines for Canadian Recreational Water Quality of 400 MPN/100ml (Sample 4, 5, 10 and 4(2)). Sample 4(2) was collected to confirm the first sample (4) as this sample was result was considerably high. Sample No. 4 was taken at the beginning of the rain event on October 11th, 2018 whereas the sample No. 4(2) was taken midway through the rain event of November 2, 2018. All sample locations are shown on **Drawings 18292-00P-C03 (p.24)**.

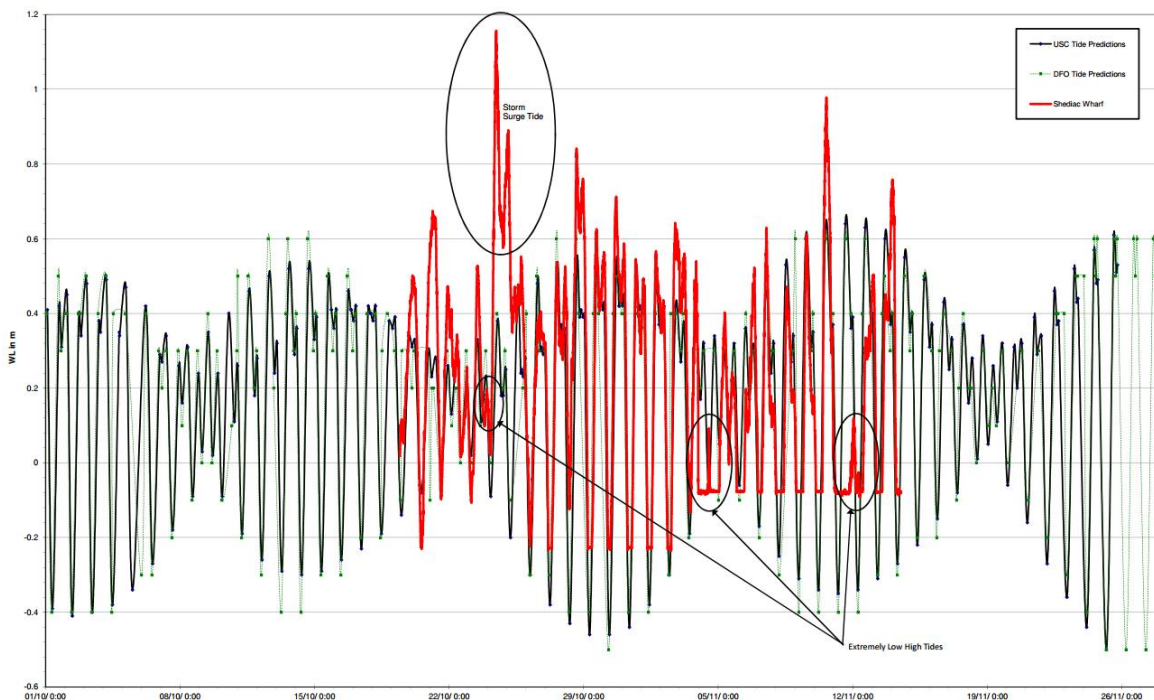
Figure 3-1: Measured Tide vs. Tide Predictions (October and November 2018)

A comparison of actual measured tidal water levels, with measured water levels, shows that tidal water levels are significantly affected by wind forces. On October 24, 2018, the measured tide was close to 1.2 m, resulting from a small storm surge, while the predicted tide would have been only at 0.6m. Conversely, on November 4, the measured high tide was at +0.1 m geodetic where the predicted tide was at +0.5m geodetic.

Dredging of the inlet lower than +0.2 m geodetic will allow more flow, during rising tides, to enter the channel faster, since there is a restricted section at the inlet the water, within the channel, does not reach the same tide level as the Northumberland Strait before tides begin to drop. As a result, this maintains a lower water level within the channel and Lagoon as shown on **Figure 3-1**.

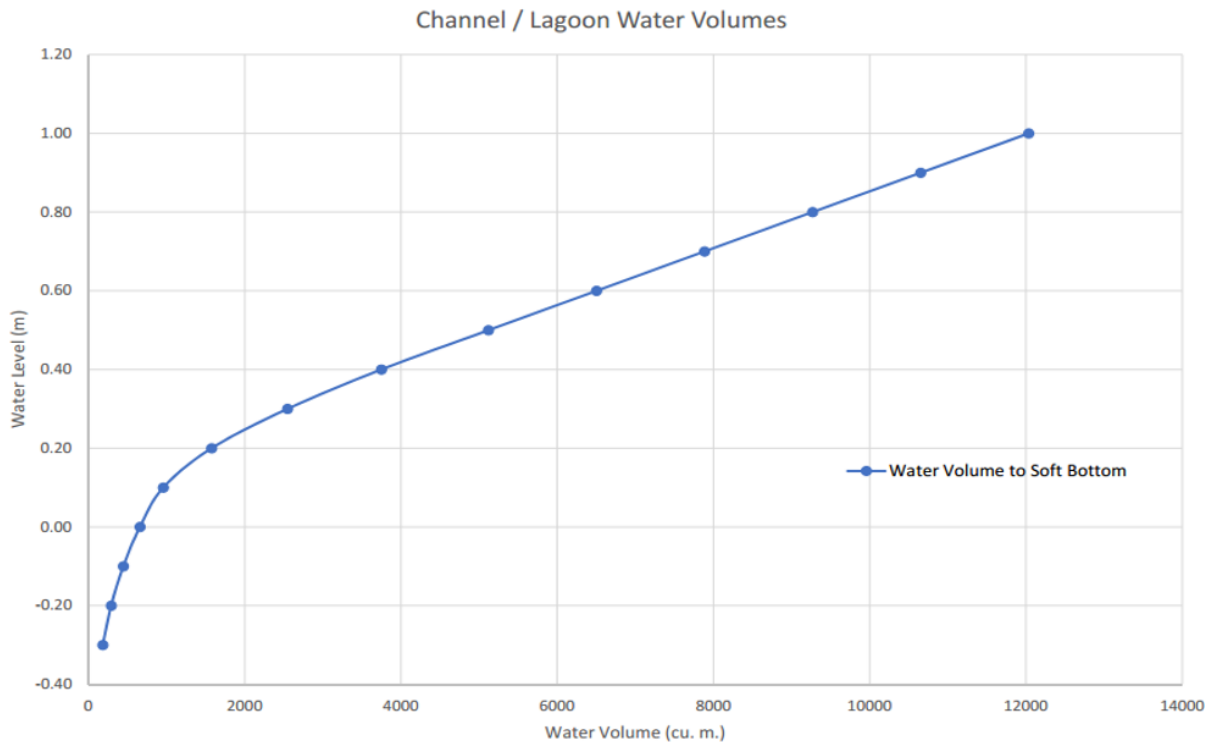
Figure 3-4: Lagoon / Channel Water Volume Curve

The amount of water flushing in and out of the channel/lagoon can be assessed using the storage volume curve shown in **Figure 3-4**. Given an average tidal range of 0.3 m – 0.4 m in the channel/lagoon results in a flushing volume of **5,000 m³ per tide**. This translates into a flow of **660 m³/hr or 0.2 m³/sec**.
